CEMETERY SURVEY FORM

SITE NAME: Satala Naval Cemetery

PLOT IDENTIFICATION: 10

NAME(S) OF INTERRED: W. C. McGEE

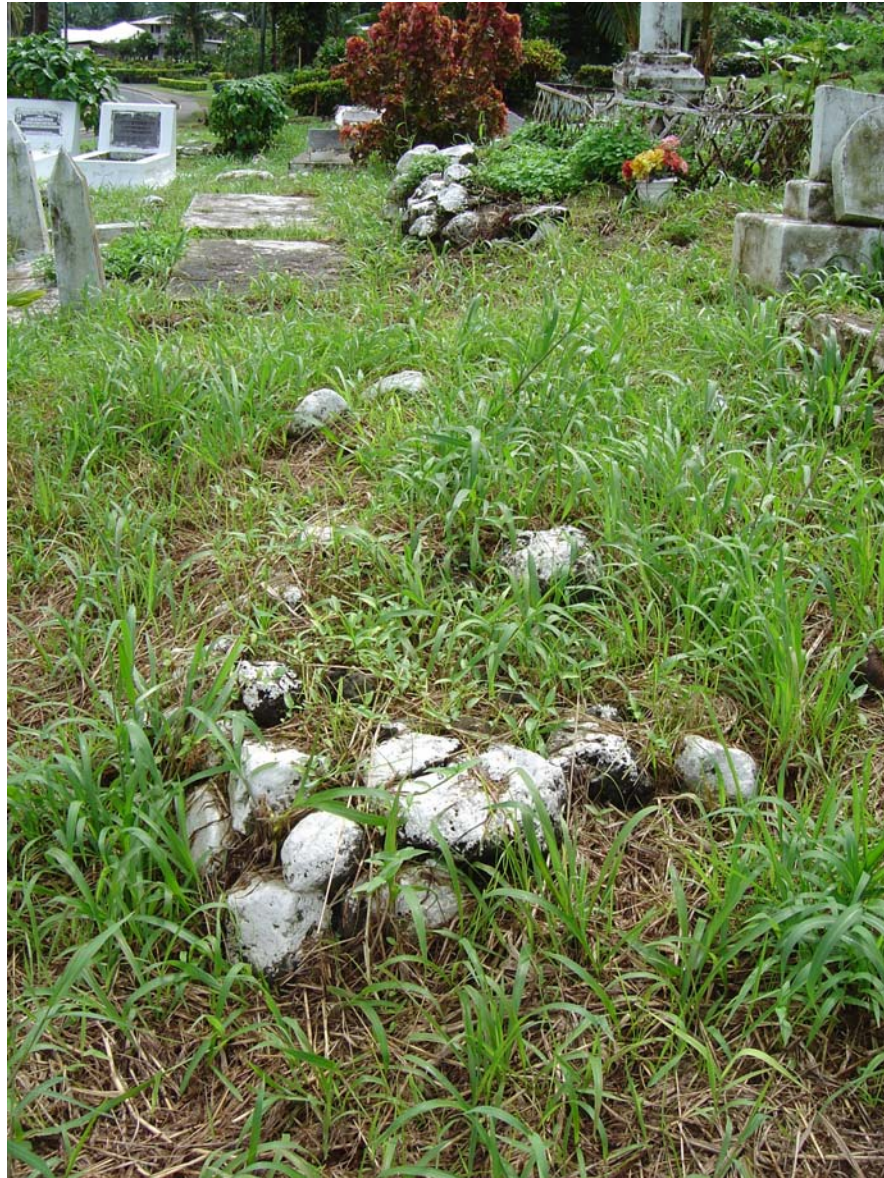
PHOTO:

SUMMARY: Fallen portion from S side stacking; visible painted rock outline
overgrown with grass on entire grave.

hazardous/immediate action **unstable deterioration/ASAP**
