CEMETERY SURVEY FORM

SITE NAME: Satala Naval Cemetery (AS-25-055)

PLOT IDENTIFICATION: 100

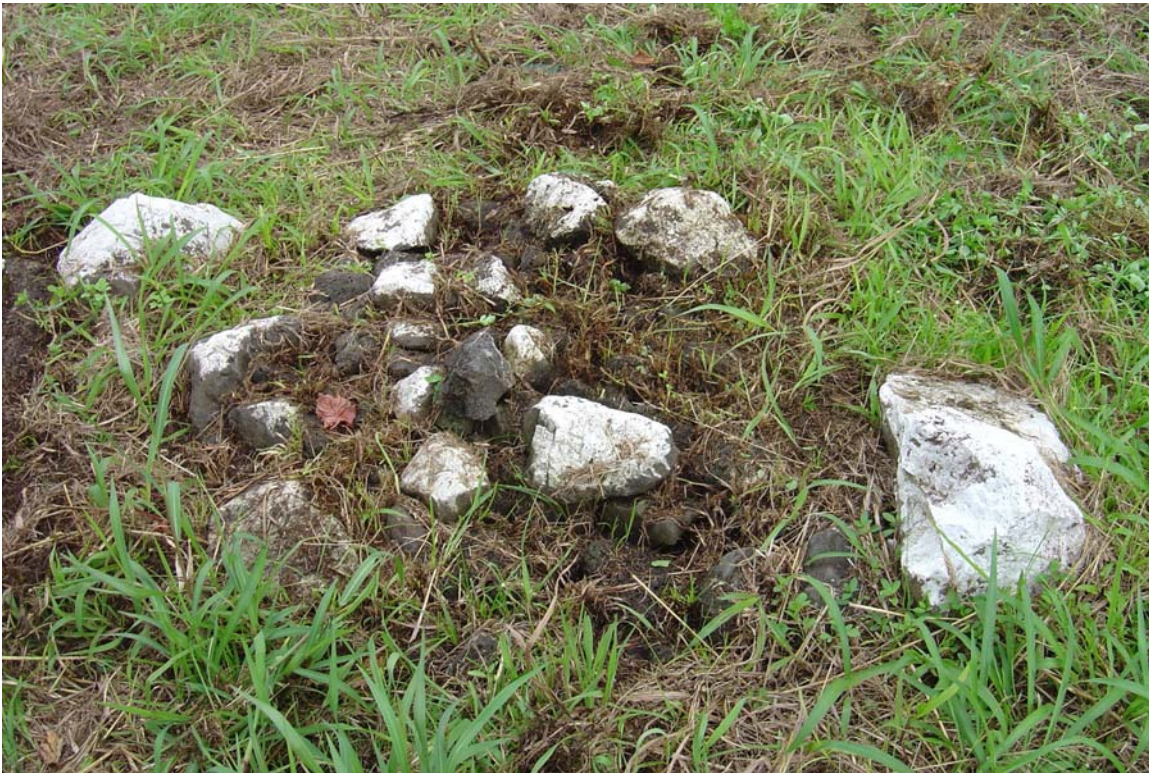
PHOTO:

SUMMARY: The primary structure consists of a basalt rock oval outline with basalt paving. The grave is covered in white paint and weeds. Paint and weeds should be removed.
