CEMETERY SURVEY FORM

SITE NAME: Satala Naval Cemetery (AS-25-055)

PLOT IDENTIFICATION: 101

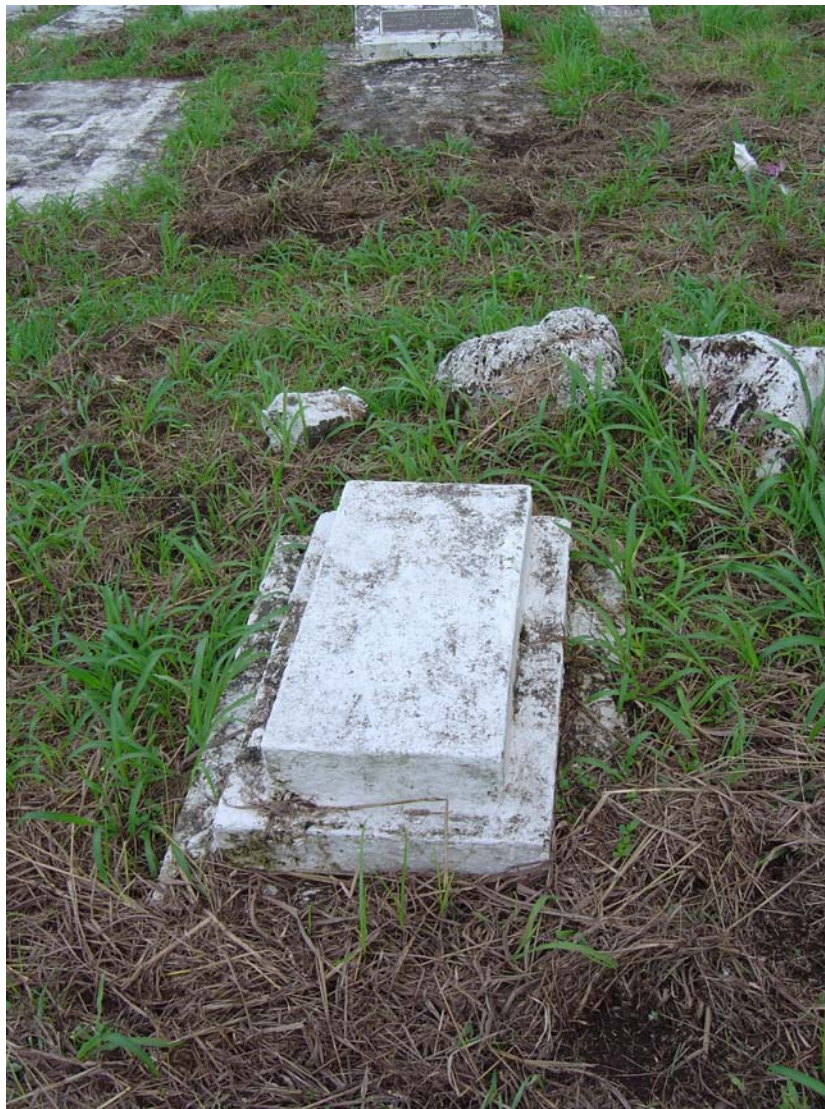
PHOTO:

SUMMARY: The entire grave is covered in layers of thick, flaking, and peeling white paint and mildew. Paint and mildew should be removed. There are four holes, one in each corner of the base, that may indicate possible posts for a chain or rope.

ongoing deterioration/treatment required 2-5 years **re-inspect in 5 years**
