CEMETERY SURVEY FORM

SITE NAME: Satala Naval Cemetery (AS-25-055)

PLOT IDENTIFICATION: 104

NAME(S) OF INTERRED: Fusanichi Morisawa

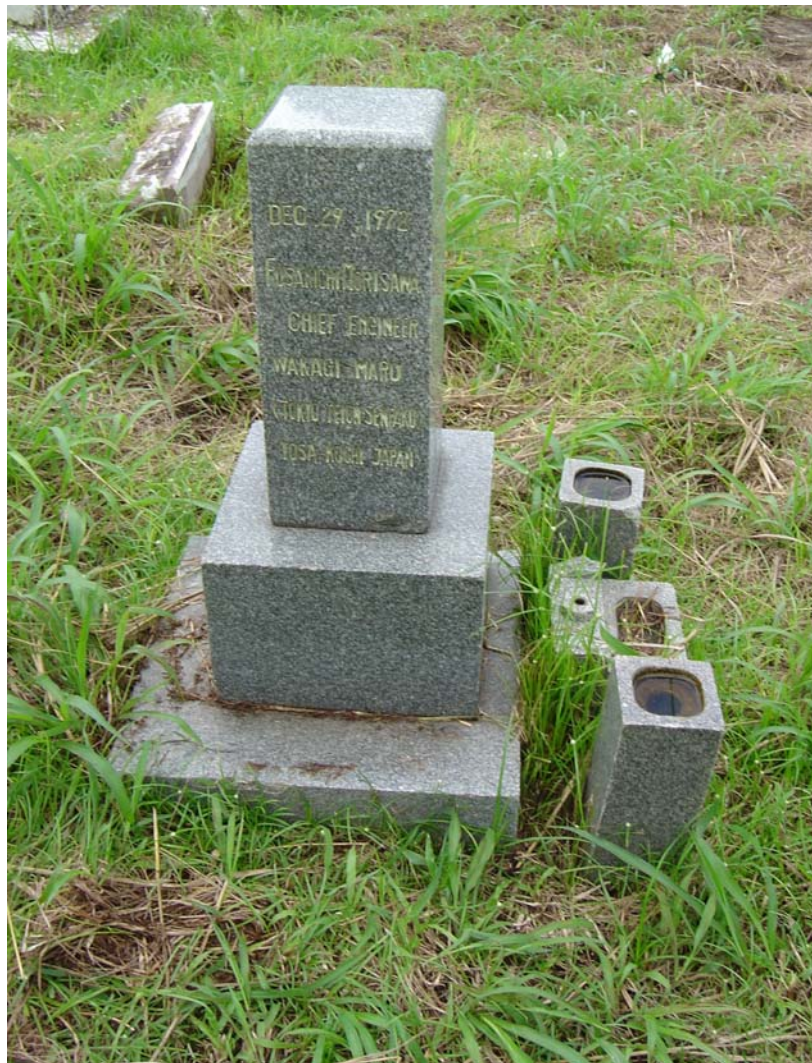
PHOTO:

SUMMARY: A small piece of the marker is missing in the southwest corner. The inscription has some biological staining around the lettering. The staining should be cleaned off. The missing piece is not available to repair.
