CEMETERY SURVEY FORM

SITE NAME: Satala Naval Cemetery (AS-25-055)

PLOT IDENTIFICATION: 105

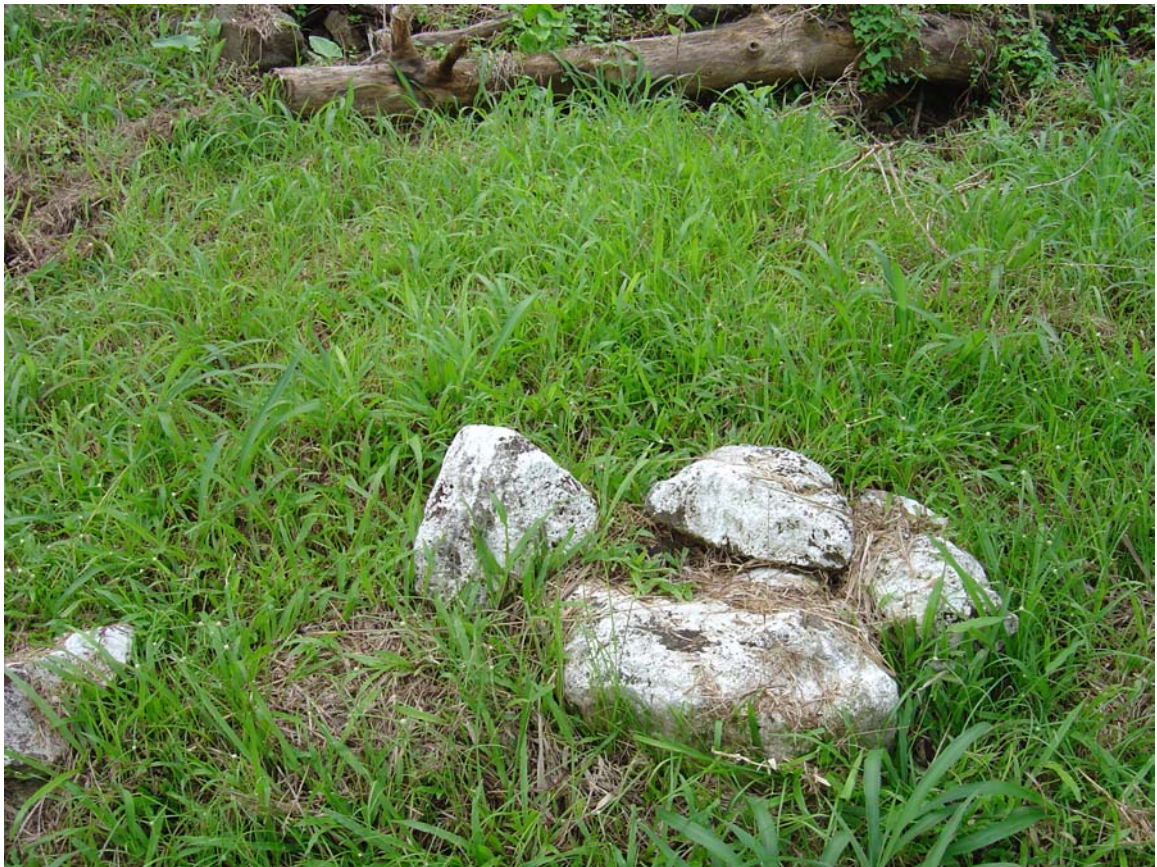
SUMMARY: The rock mound is completely overgrown and needs to be weeded. White paint covers the visible rocks and should be removed.
