CEMETERY SURVEY FORM

SITE NAME: Satala Naval Cemetery (AS-25-055)

PLOT IDENTIFICATION: 106

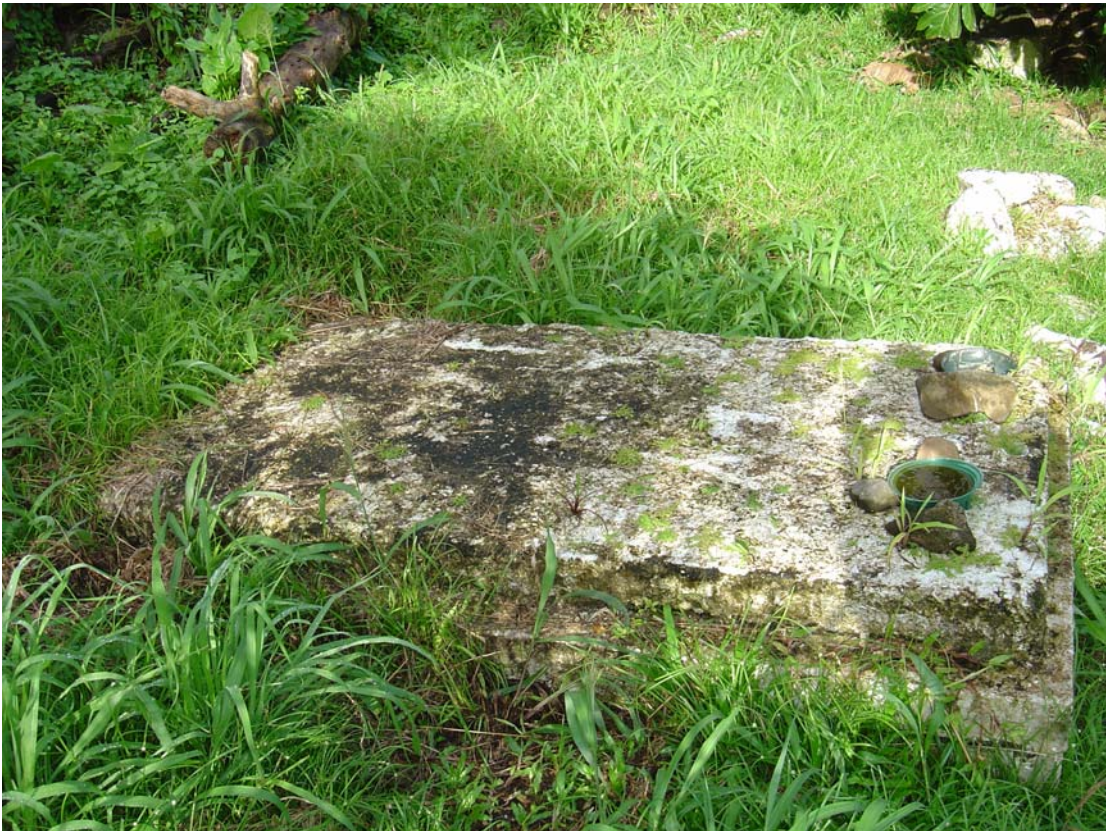
PHOTO:

SUMMARY: The concrete slab top cover is covered in layers of thick white paint and the painted surface has mildew patches. The concrete underneath has a rough surface which may indicate losses of concrete or covered decorations. There are cracks with growing vegetation in the paint layers and the cover and base of the vault are separating. Mildew should be washed off and painted should be removed. Concrete should be examined after exposure.
