CEMETERY SURVEY FORM

SITE NAME: Satala Naval Cemetery (AS-25-055)

LOCATION: Maoputasi County, Tutuila Island, American Samoa

PLOT IDENTIFICATION: 107

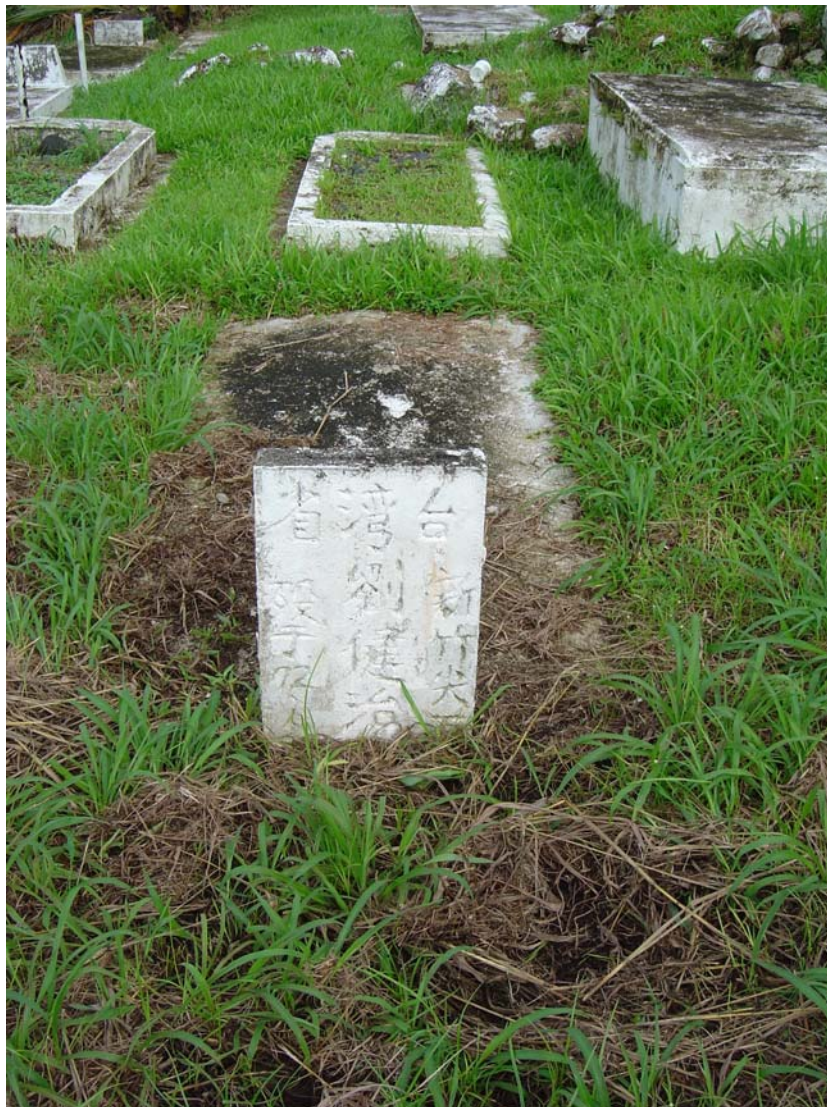
PHOTO:

SUMMARY: The slab and footstone are covered in layers of thick white paint and the painted surface has mildew patches. Thicker layers of latex paint were removed by hand from the footstone to read the inscription. Mildew should be washed off and painted should be removed. Vegetation has grown up around base and needs to be cleared.
