CEMETERY SURVEY FORM

SITE NAME: Satala Naval Cemetery

PLOT IDENTIFICATION: 11

NAME(S) OF INTERRED: CEDRIC DEBELLE INFANT

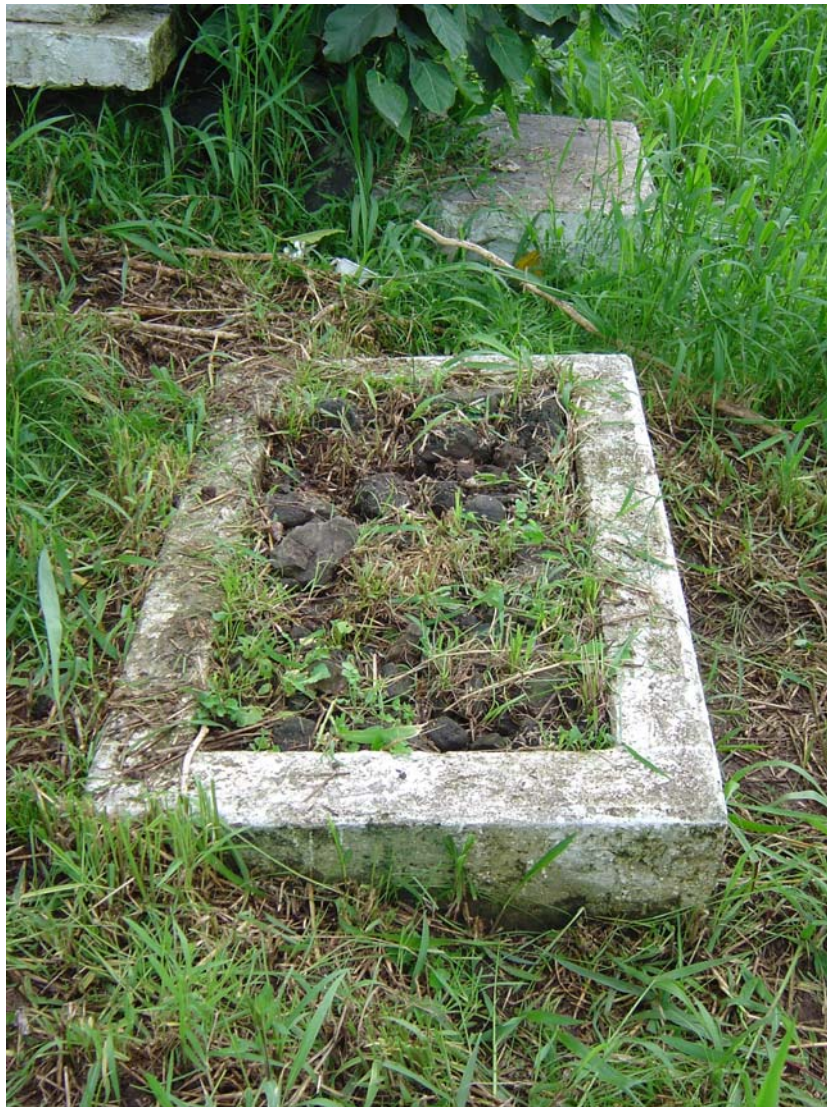
PHOTO:

SUMMARY: Open concrete frame filled with basalt cobbles. Overgrown; concrete portion covered in thick, flaking, white paint.
