CEMETERY SURVEY FORM

SITE NAME: Satala Naval Cemetery (AS-25-055)

PLOT IDENTIFICATION: 111

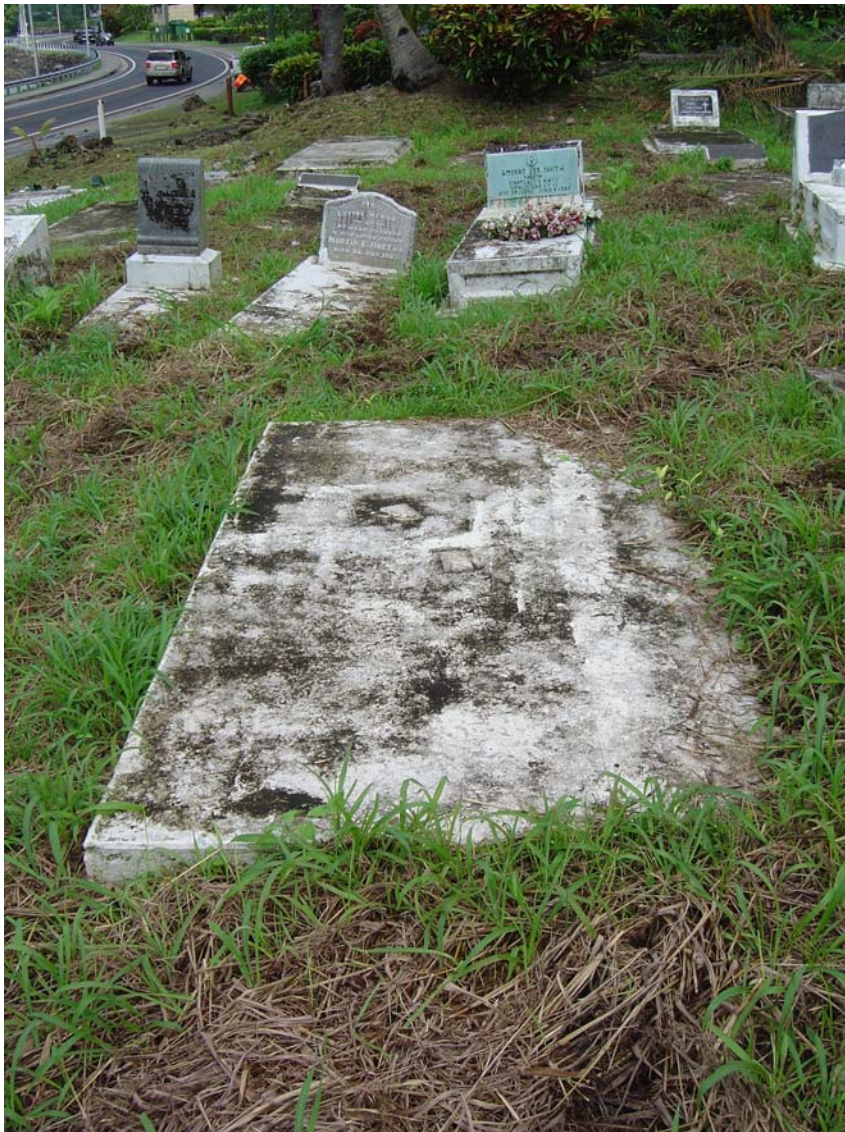
PHOTO:

SUMMARY: Rectangular concrete slab covered in flaking white paint. N edge overgrown, possibly sinking.

ongoing deterioration/treatment required 2-5 years **re-inspect in 5 years**
