CEMETERY SURVEY FORM

SITE NAME: Satala Naval Cemetery (AS-25-055)

PLOT IDENTIFICATION: 113

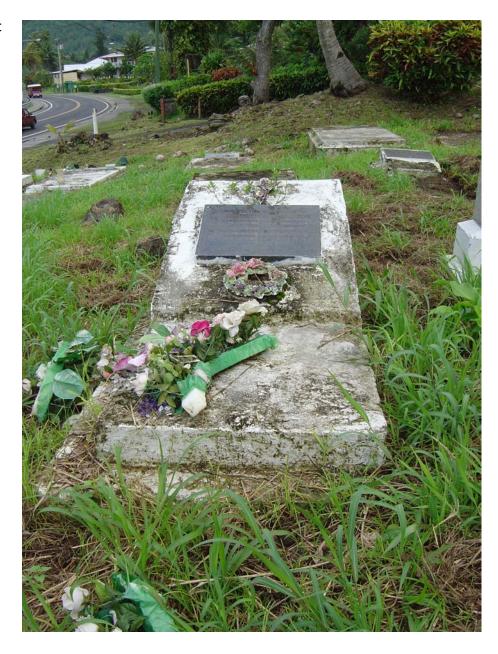
PHOTO:

SUMMARY: Covered in flaking white paint and mildew; headstone edges also painted.
