# CEMETERY SURVEY FORM

SITE NAME: Satala Naval Cemetery (AS-25-055)

PLOT IDENTIFICATION: 114

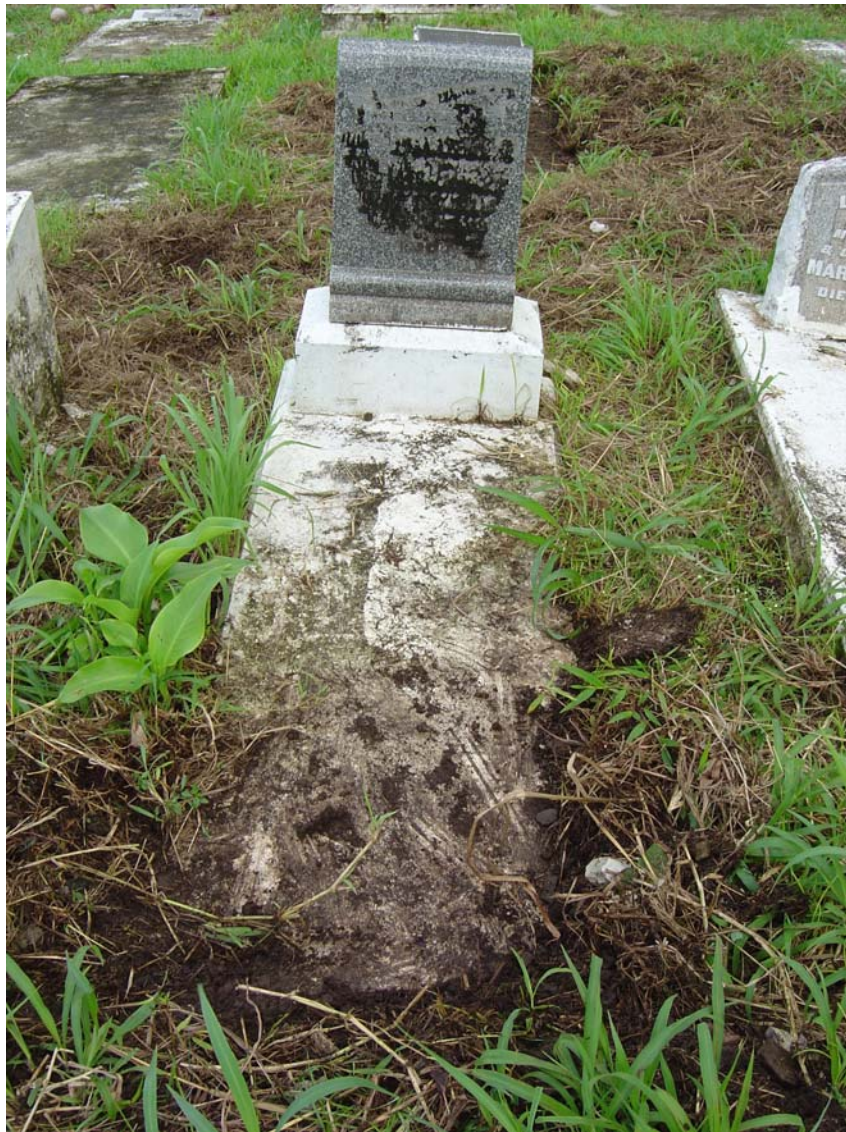
PHOTO:

EXISTING CONDITION	CONSERVATION STRATEGY
<p>POSITION: fallen unstable overgrown tilted marker/ base other _____</p> <p>DETERIORATION: broken cracked losses flaking/sugaring delaminations/detachment other _____</p> <p>SOILING: biological general graffiti efflorescence painting other</p> <p>FAILED TREATMENTS: metal adhesives/coatings mortar other _____</p>	<p>POSITION: reset in ground reset to existing base resquare botom edge remove fragments in setting slot construct new base possible new base required stabilize foundation</p> <p>DETERIORATION: structural adhesion repair mortars crack fillers flowable grouts consolidation</p> <p>SOILING: chemical pressure wash poultice air abrasion</p> <p>FAILED TREATMENTS: drill/grind hand tools solvents air abrasion</p>

SUMMARY: Granite pedestal for headstone has been painted white. Entire grave sinking along N edge.

**ongoing deterioration/treatment required 2-5 years**    re-inspect in 5 years
