# CEMETERY SURVEY FORM

SITE NAME: Satala Naval Cemetery (AS-25-055)

PLOT IDENTIFICATION: 115

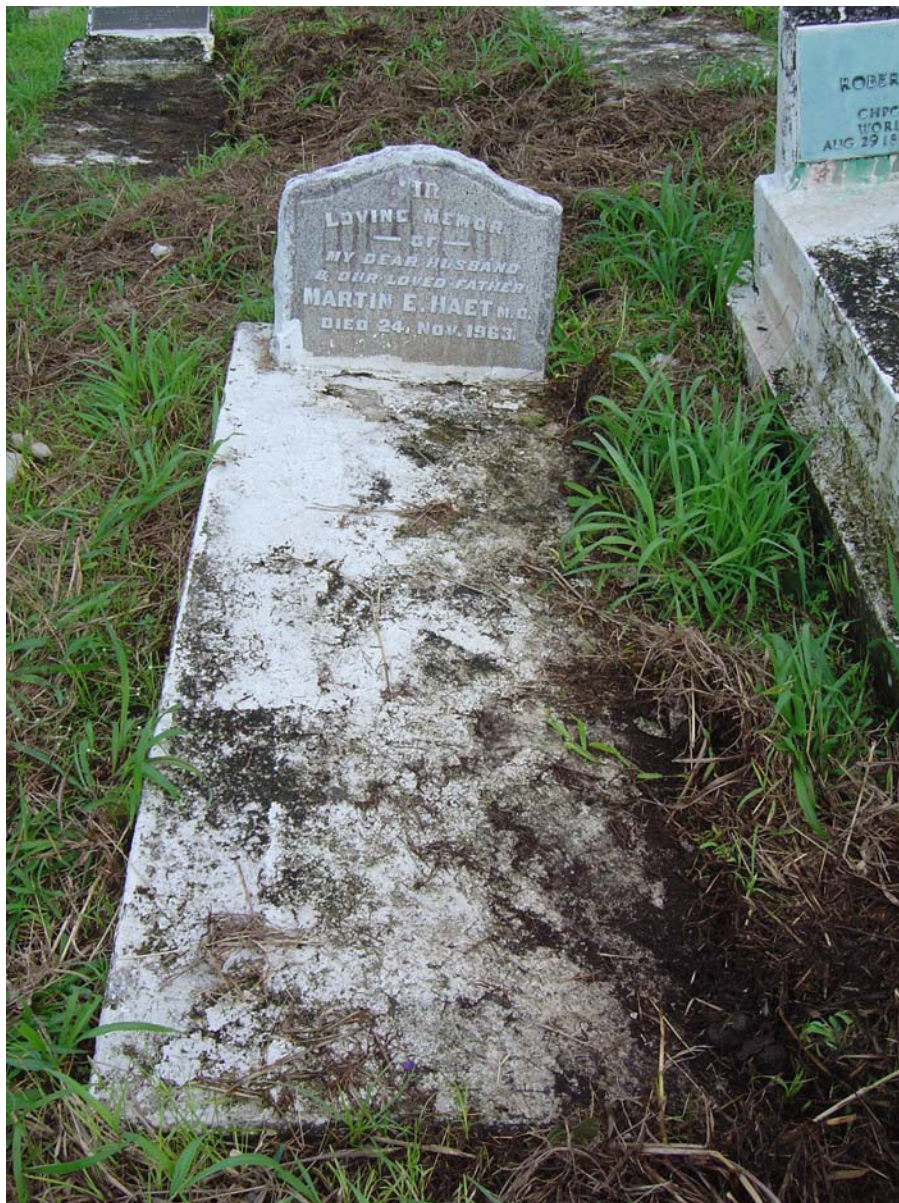
PHOTO:

SUMMARY: Sunken on N edge (upslope); white paint flaking; concrete intact. Possible “Y” missing from headstone; chipped “D” in M.D.
