# CEMETERY SURVEY FORM

SITE NAME: Satala Naval Cemetery (AS-25-055)

PLOT IDENTIFICATION: 116

NAME(S) OF INTERRED: ROBERT LEE SMITH

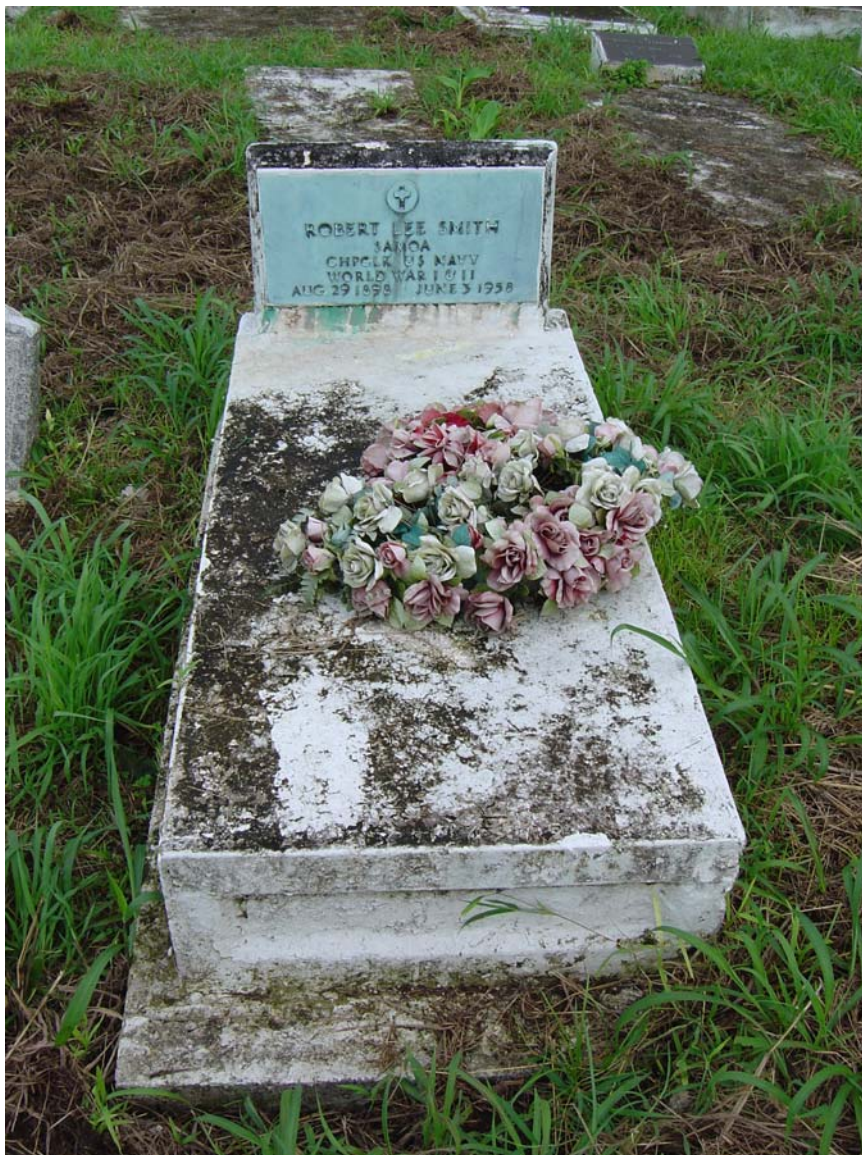
PHOTO:

EXISTING CONDITION	CONSERVATION STRATEGY
<p>POSITION: fallen unstable <b>overgrown</b> <b>tilted marker/ base</b> other _____</p> <p>DETERIORATION: broken cracked losses flaking/sugaring delaminations/detachment other _____</p> <p>SOILING: <b>biological</b> general graffiti efflorescence <b>painting</b> other</p> <p>FAILED TREATMENTS: metal adhesives/coatings mortar other _____</p>	<p>POSITION: reset in ground reset to existing base resquare botom edge remove fragments in setting slot construct new base possible new base required stabilize foundation</p> <p>DETERIORATION: structural adhesion repair mortars crack fillers flowable grouts consolidation</p> <p>SOILING: chemical pressure wash poultice air abrasion</p> <p>FAILED TREATMENTS: drill/grind hand tools solvents air abrasion</p>

SUMMARY: Tilting/sinking down on S edge; thick white paint flaking; metal plaque is green.
