CEMETERY SURVEY FORM

SITE NAME: Satala Naval Cemetery (AS-25-055)

LOCATION: Maoputasi County, Tutuila Island, American Samoa

PLOT IDENTIFICATION: 118

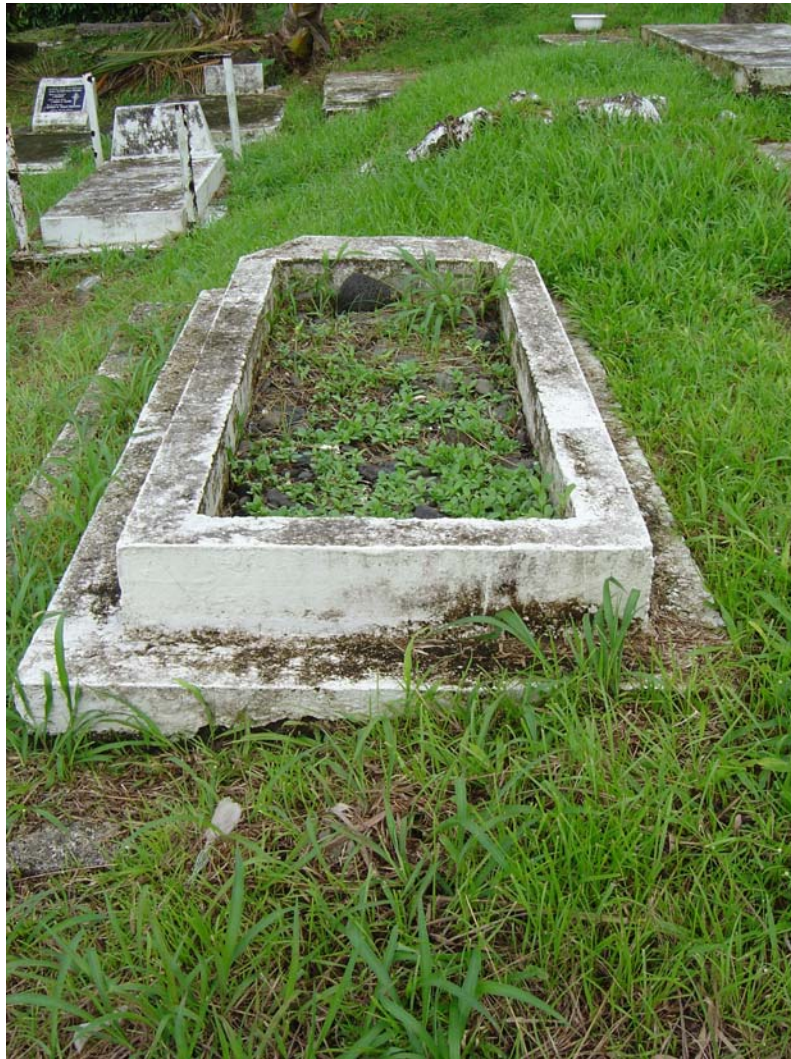
PHOTO:

SUMMARY: Twin style of 119; curb runs along S edge and “disappears” upslope. Bedstead filled with waterworn basalt cobbles and ceramic fragments (flower vase?). Grass growing inside bedstead and between base and curb; white paint peeling and flaking all over grave.

ongoing deterioration/treatment required 2-5 years **re-inspect in 5 years**
