# CEMETERY SURVEY FORM

SITE NAME: Satala Naval Cemetery

PLOT IDENTIFICATION: 12

NAME(S) OF INTERRED: BRYAN INFANT

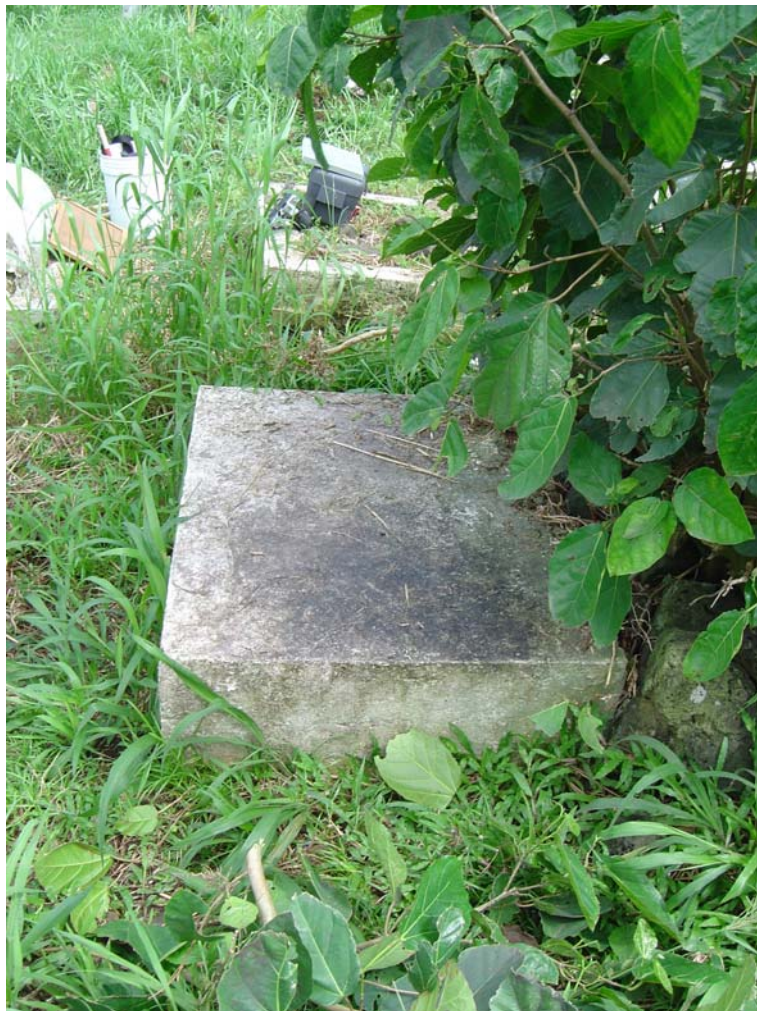
PHOTO:

EXISTING CONDITION	CONSERVATION STRATEGY
<p>POSITION: fallen unstable <b>overgrown</b> tilted marker/ base other _____</p> <p>DETERIORATION: ----- broken cracked losses flaking/sugaring delaminations/detachment other _____</p> <p>SOILING: <b>biological</b> general graffiti efflorescence <b>painting</b> other</p> <p>FAILED TREATMENTS: ----- metal adhesives/coatings mortar other _____</p>	<p>POSITION: reset in ground reset to existing base resquare botom edge remove fragments in setting slot construct new base possible new base required stabilize foundation</p> <p>DETERIORATION: structural adhesion repair mortars crack fillers flowable grouts consolidation</p> <p>SOILING: chemical pressure wash poultice air abrasion</p> <p>FAILED TREATMENTS: drill/grind hand tools solvents air abrasion</p>

SUMMARY: Paint and mildew need to be removed; large shrub overgrowing this grave, 13 and 15.

ongoing deterioration/treatment required 2-5 years    **re-inspect in 5 years**
