CEMETERY SURVEY FORM

SITE NAME: Satala Naval Cemetery (AS-25-055)

PLOT IDENTIFICATION: 120

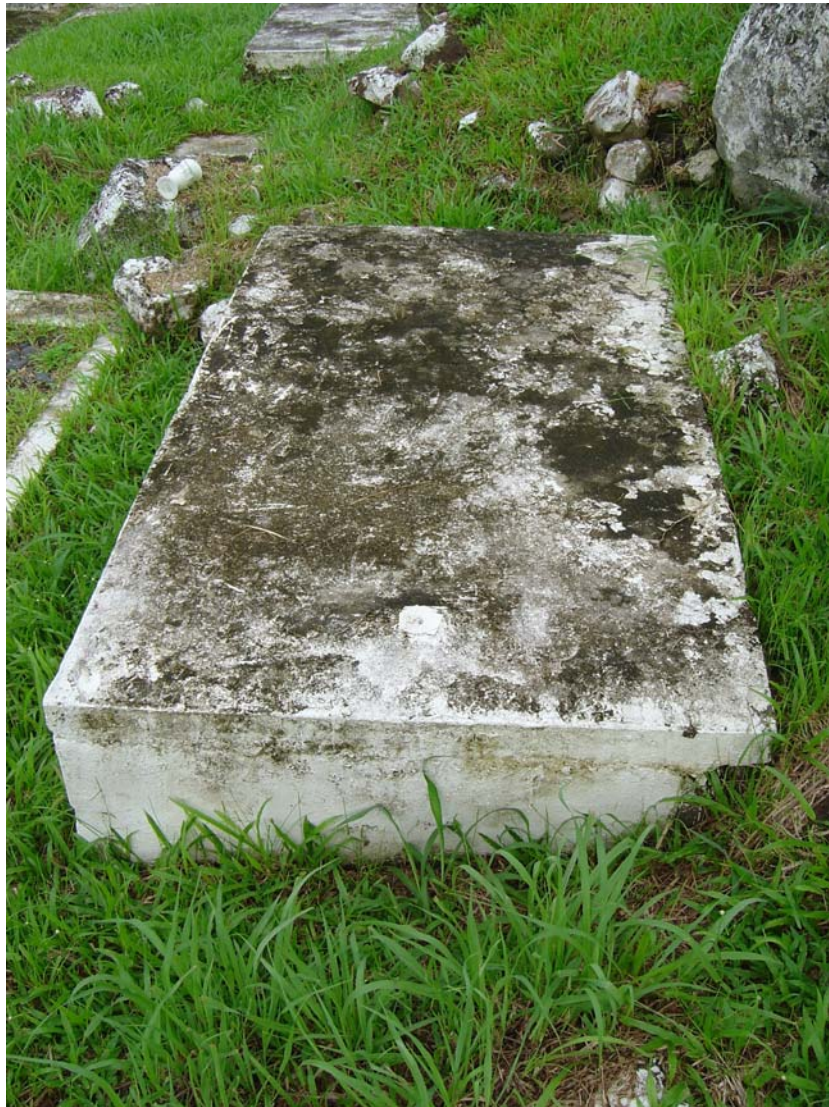
PHOTO:

SUMMARY: NE corner broken (landslide?); possible fixture for sculpture remains on E side top; flaking of white paint. Vegetation growing in crack between base and cover, possible resealing job that didn't hold to close vault.
