## CEMETERY SURVEY FORM

SITE NAME: Satala Naval Cemetery (AS-25-055)

PLOT IDENTIFICATION: 121

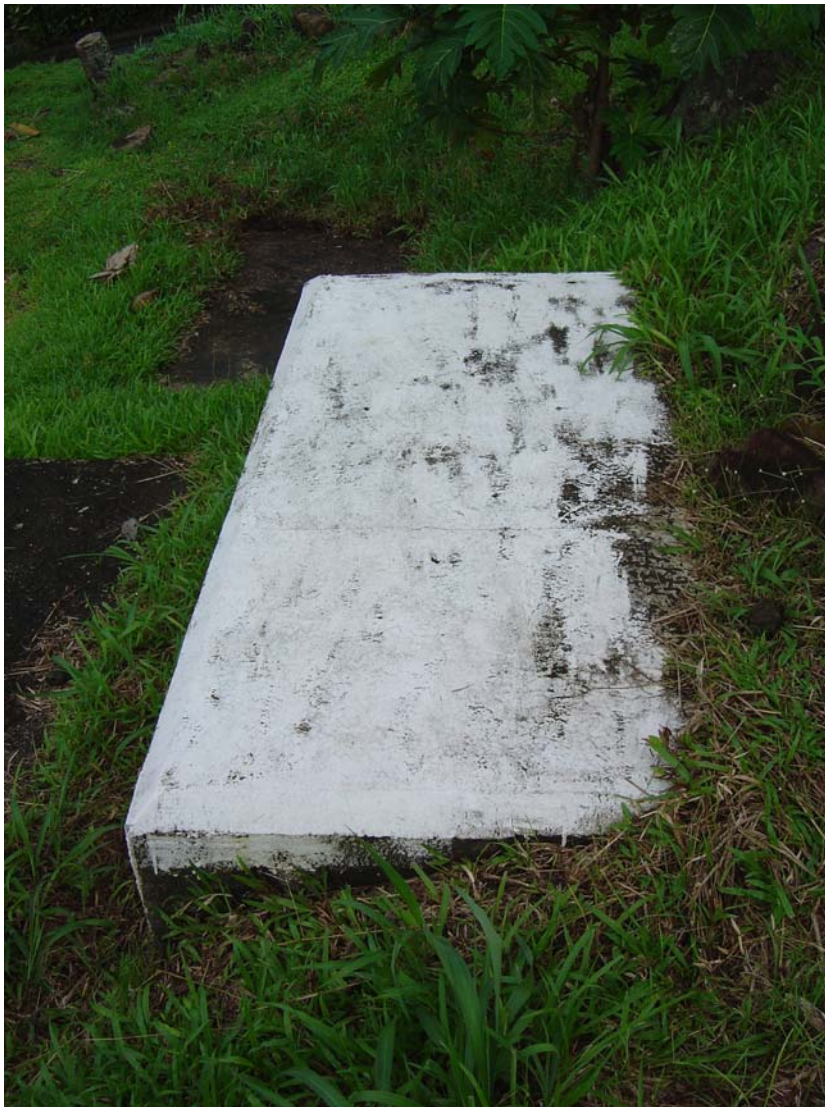
PHOTO:

EXISTING CONDITION	CONSERVATION STRATEGY
<p>POSITION: fallen unstable <b>overgrown</b> tilted marker/ base other _____</p> <p>DETERIORATION: broken cracked losses flaking/sugaring delaminations/detachment other _____</p> <p>SOILING: <b>biological</b> general graffiti efflorescence <b>painting</b> other</p> <p>FAILED TREATMENTS: metal adhesives/coatings mortar other _____</p>	<p>POSITION: reset in ground reset to existing base resquare botom edge remove fragments in setting slot construct new base possible new base required stabilize foundation</p> <p>DETERIORATION: structural adhesion repair mortars crack fillers flowable grouts consolidation</p> <p>SOILING: chemical pressure wash poultice air abrasion</p> <p>FAILED TREATMENTS: drill/grind hand tools solvents air abrasion</p>

SUMMARY: Overgrown on N and E sides; one small crack across cover. White paint flaking; cover has beveled edges.

ongoing deterioration/treatment required 2-5 years    **re-inspect in 5 years**
