CEMETERY SURVEY FORM

SITE NAME: Satala Naval Cemetery (AS-25-055)

PLOT IDENTIFICATION: 122

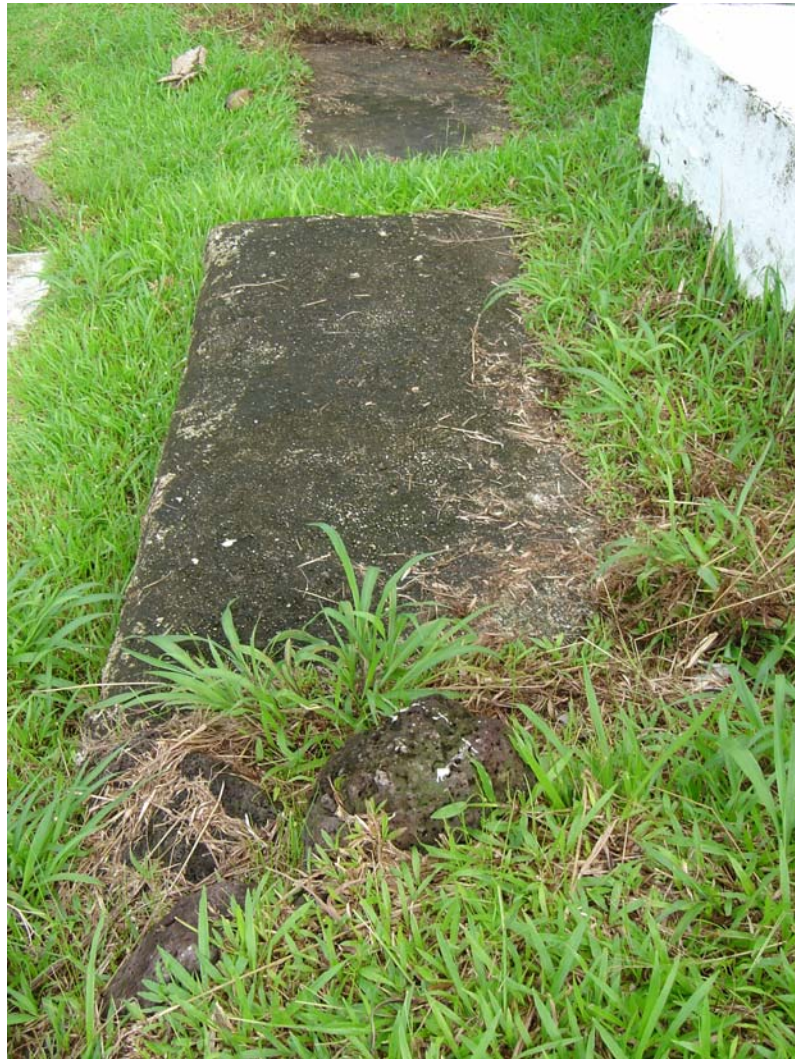
PHOTO:

SUMMARY: Entire grave covered in mildew/moss vegetation; small paint flakes remaining all over; N and E sides overgrown; concrete aggregate consists of gravel creating rough texture to concrete unlike other concrete slabs.
