CEMETERY SURVEY FORM

SITE NAME: Satala Naval Cemetery (AS-25-055)

PLOT IDENTIFICATION: 123

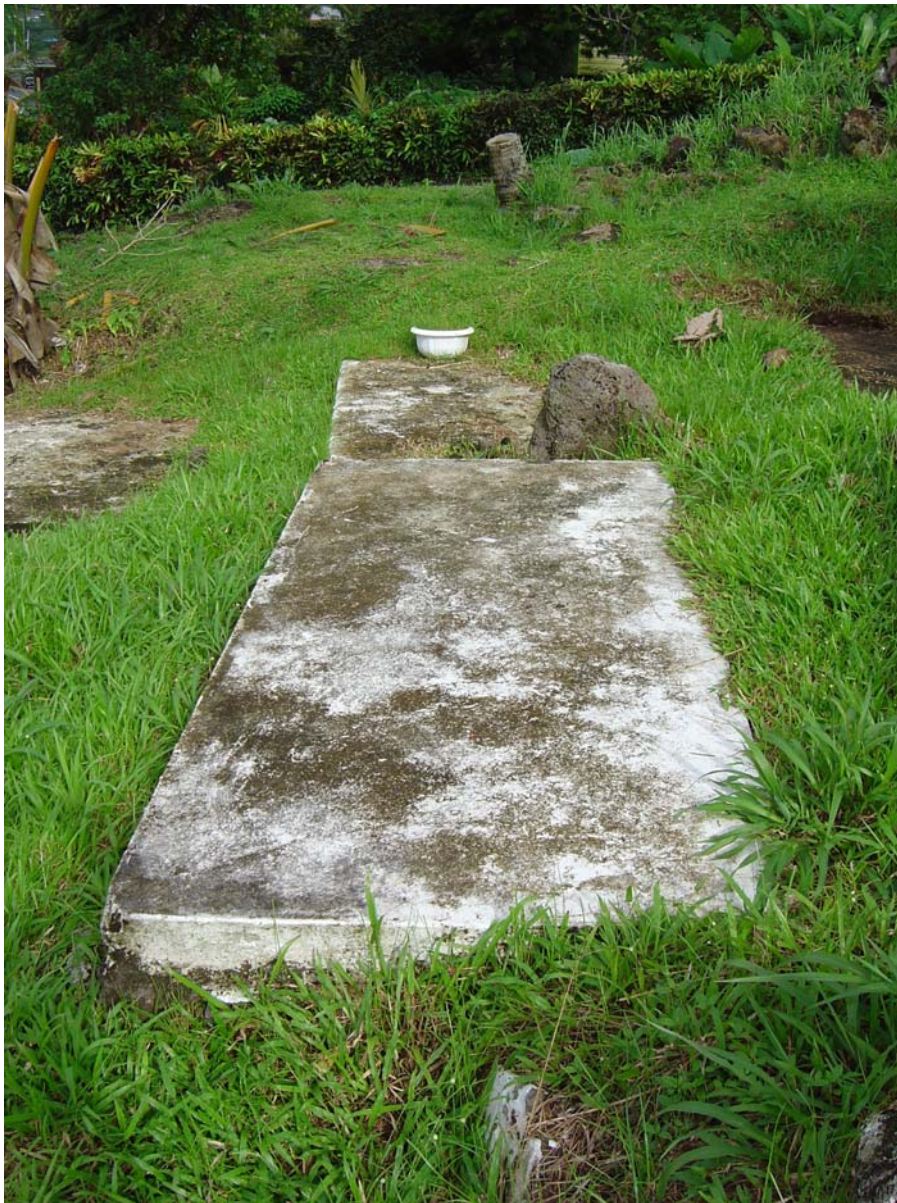
PHOTO:

SUMMARY: Some cracking on surface, possibly paint layers; broken pieces off of SW corner. NW corner has large basalt boulder, unknown purpose.
