CEMETERY SURVEY FORM

SITE NAME: Satala Naval Cemetery (AS-25-055)

PLOT IDENTIFICATION: 124

NAME(S) OF INTERRED: TEODORO MIRADA

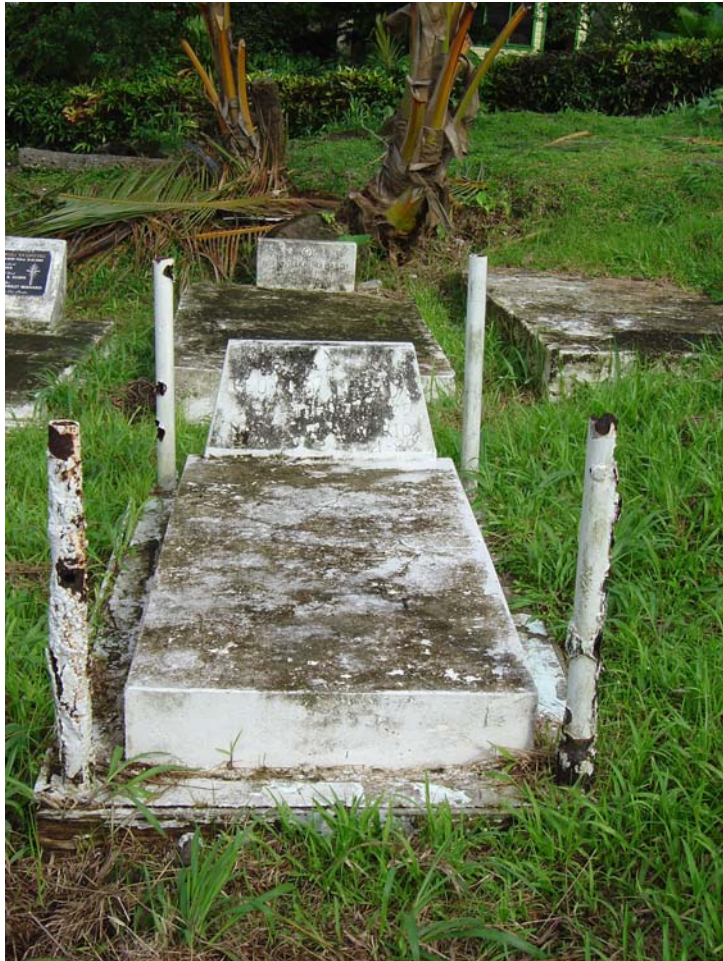
PHOTO:

SUMMARY: Inscription on headstone is difficult to read – layers of painting; white paint flaking off headstone, base, primary structure, and post; S side of primary structure revealing blue paint beneath white; the forms/edge of base are wooden boards on all four sides; posts at each corner are badly rusted; unknown if posts supported a roof or an enclosing chain; small curb of basalt rocks outlines base; possible cracks in surface of primary structure (most likely in paint layers, not concrete).
