CEMETERY SURVEY FORM

SITE NAME: Satala Naval Cemetery (AS-25-055)

PLOT IDENTIFICATION: 125

NAME(S) OF INTERRED: JAMES C. FLANNERY

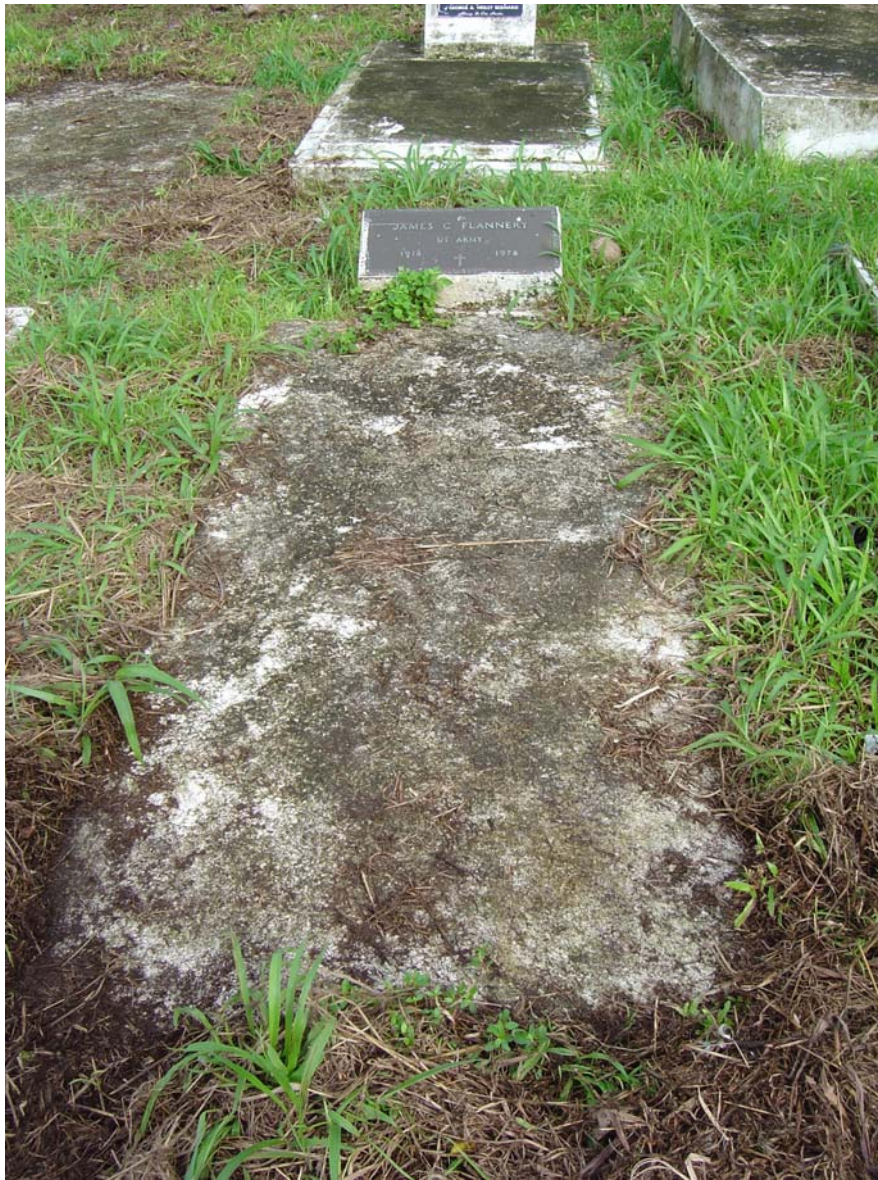
PHOTO:

SUMMARY: Paint on plaque and entire grave is flaking; some small cracks in the headstone.
