CEMETERY SURVEY FORM

SITE NAME: Satala Naval Cemetery (AS-25-055)

LOCATION: Maoputasi County, Tutuila Island, American Samoa

PLOT IDENTIFICATION: 126

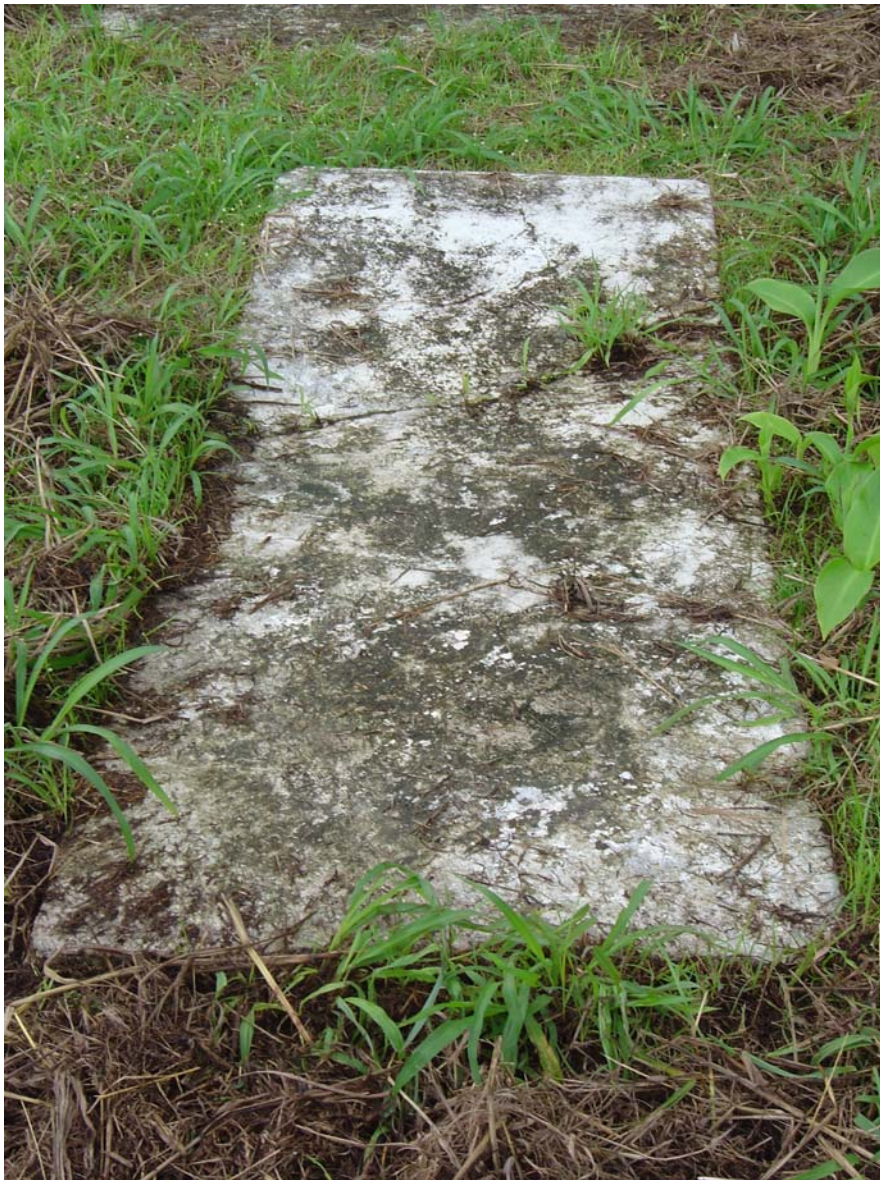
PHOTO:

EXISTING CONDITION	CONSERVATION STRATEGY
<p>POSITION: fallen unstable overgrown tilted marker/ base other <u>tilted half</u></p> <p>DETERIORATION: broken cracked losses flaking/sugaring delaminations/detachment other _____</p> <p>SOILING: biological general graffiti efflorescence painting other</p> <p>FAILED TREATMENTS: metal adhesives/coatings mortar other _____</p>	<p>POSITION: reset in ground reset to existing base resquare botom edge remove fragments in setting slot construct new base possible new base required stabilize foundation</p> <p>DETERIORATION: structural adhesion repair mortars crack fillers flowable grouts consolidation</p> <p>SOILING: chemical pressure wash poultice air abrasion</p> <p>FAILED TREATMENTS: drill/grind hand tools solvents air abrasion</p>

SUMMARY: Flat concrete slab broken across at 40" in from W edge, vegetation overgrowth destabilizing broken piece; starting to break also at 68" from W edge.

hazardous/immediate action **unstable deterioration/ASAP**
