CEMETERY SURVEY FORM

SITE NAME: Satala Naval Cemetery (AS-25-055)

PLOT IDENTIFICATION: 127

NAME(S) OF INTERRED: EUGENE L. McKINLEY

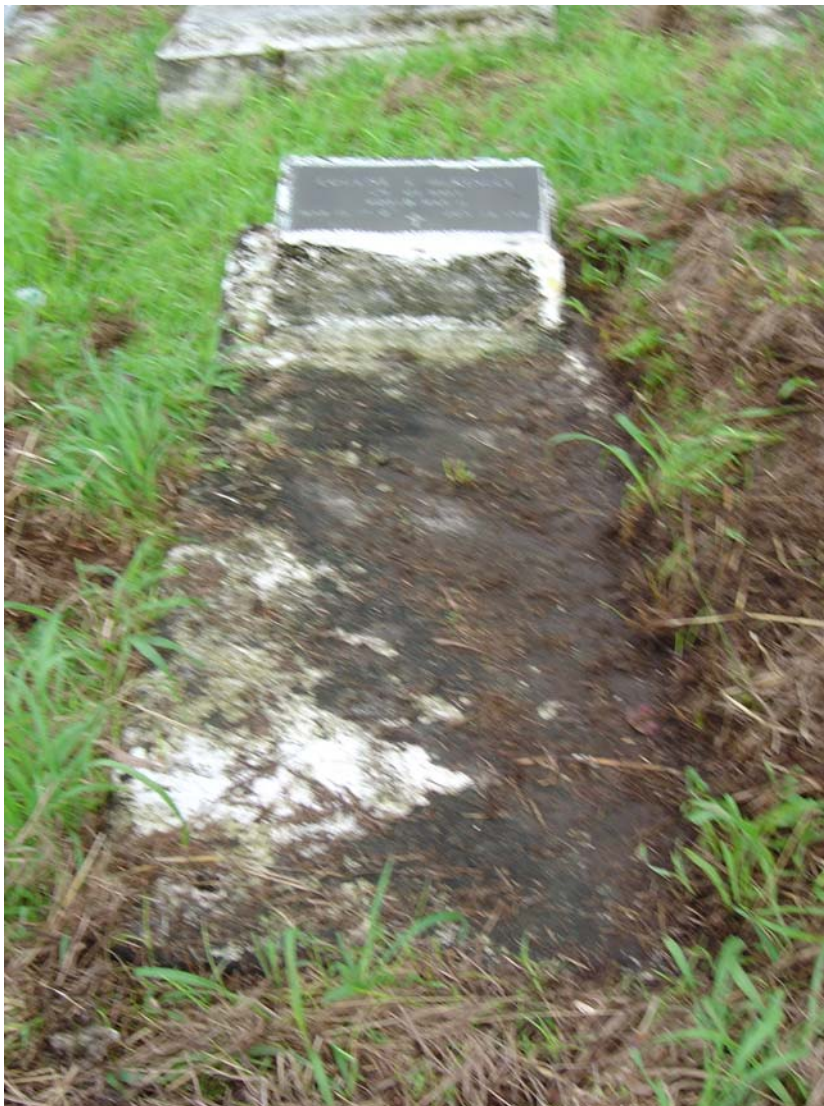
PHOTO:

EXISTING CONDITION	CONSERVATION STRATEGY
<p>POSITION: fallen unstable overgrown tilted marker/ base other <u>sunken</u></p> <p>DETERIORATION: broken cracked losses flaking/sugaring delaminations/detachment other _____</p> <p>SOILING: biological general graffiti efflorescence painting other</p> <p>FAILED TREATMENTS: metal adhesives/coatings mortar other _____</p>	<p>POSITION: reset in ground reset to existing base resquare botom edge remove fragments in setting slot construct new base possible new base required stabilize foundation</p> <p>DETERIORATION: structural adhesion repair mortars crack fillers flowable grouts consolidation</p> <p>SOILING: chemical pressure wash poultice air abrasion</p> <p>FAILED TREATMENTS: drill/grind hand tools solvents air abrasion</p>

SUMMARY: White paint on headstone and primary structure flaking and spotty. Large crack through entire width of primary structure at 36" from W edge. Entire grave tilted and sunken towards NE corner.

hazardous/immediate action **unstable deterioration/ASAP**
