CEMETERY SURVEY FORM

SITE NAME: Satala Naval Cemetery (AS-25-055)

PLOT IDENTIFICATION: 129

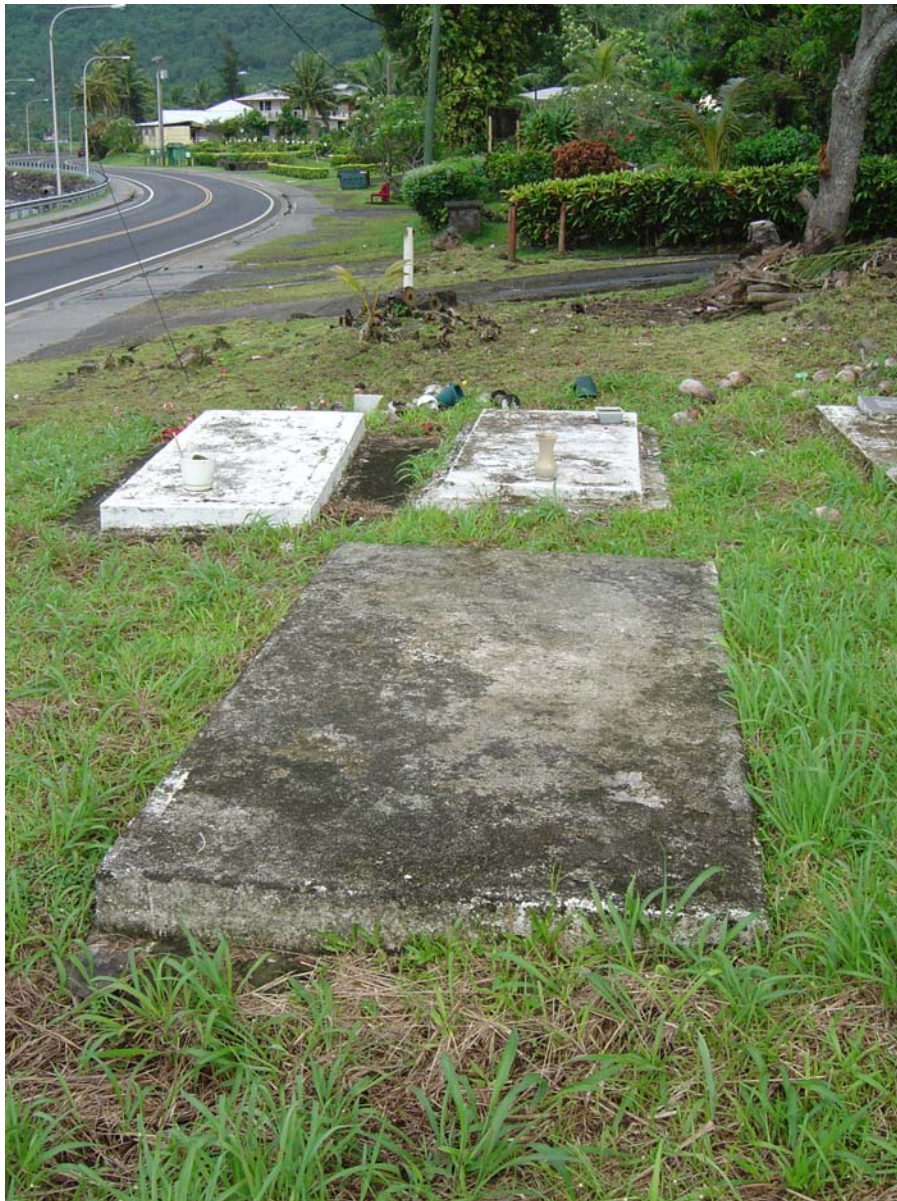
PHOTO:

SUMMARY: Primary structure and base located on top of berm? (basalt rocks, overgrown grass). White paint flaking on primary structure; no cracks or broken pieces.

ongoing deterioration/treatment required 2-5 years **re-inspect in 5 years**
