CEMETERY SURVEY FORM

SITE NAME: Satala Naval Cemetery

LOCATION: Maoputasi County, Tutuila Island, American Samoa

PLOT IDENTIFICATION: 13

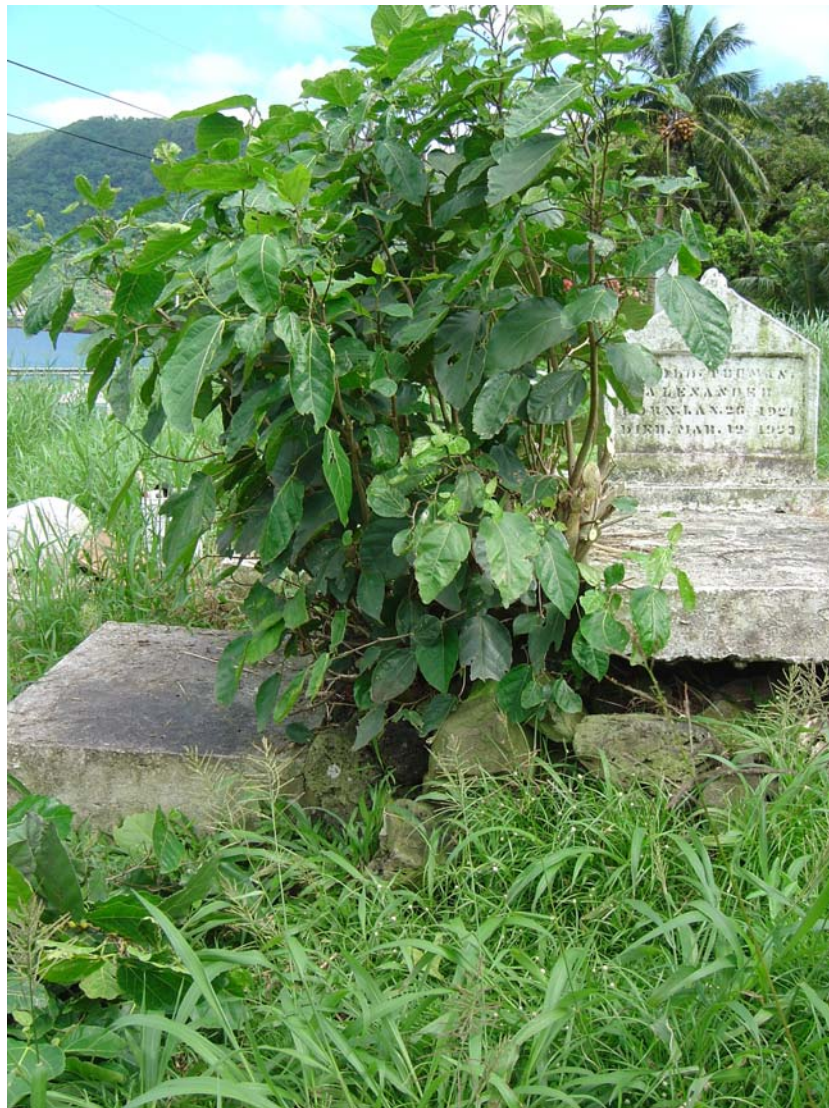
PHOTO:

SUMMARY: Rockmound slightly overgrown; small cross lying on top, broken and not in original position may have come off of #15 headstone? Large ornamental shrub growing out of center.
