CEMETERY SURVEY FORM

SITE NAME: Satala Naval Cemetery (AS-25-055)

LOCATION: Maoputasi County, Tutuila Island, American Samoa

PLOT IDENTIFICATION: 133

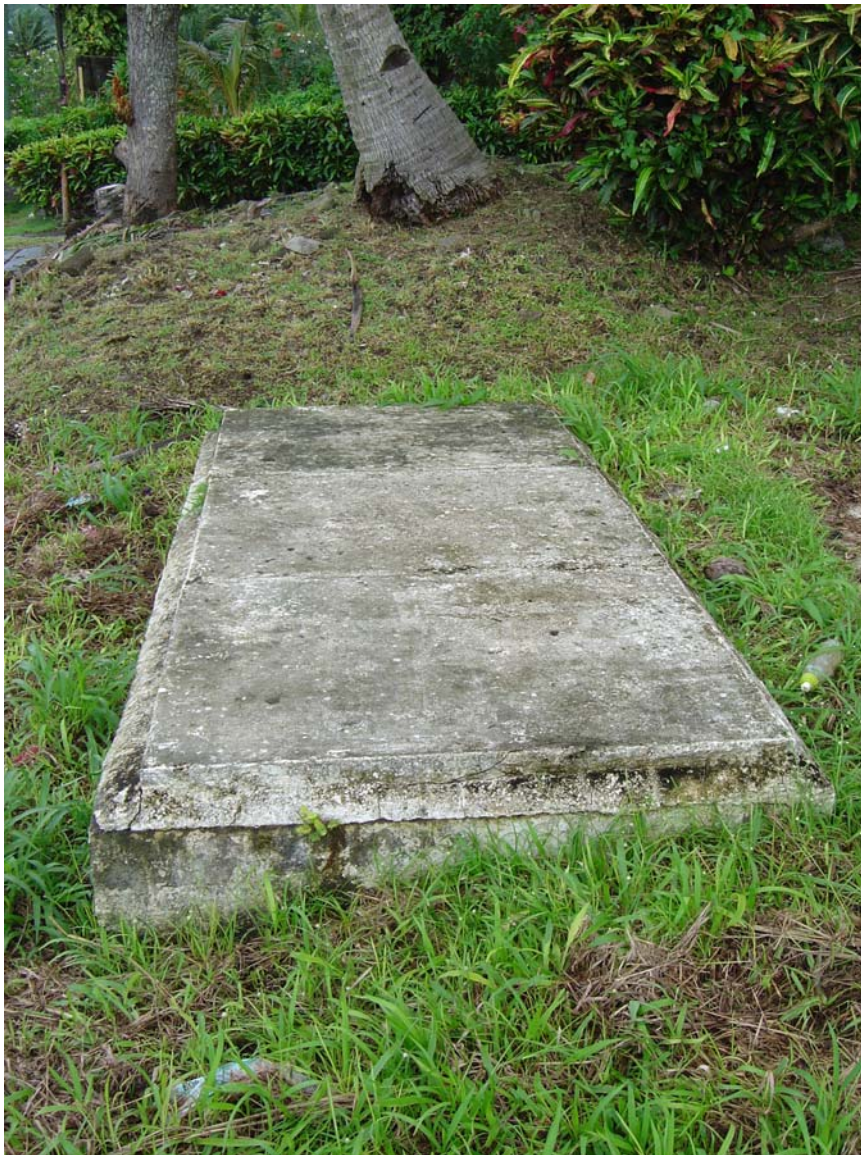
PHOTO:

SUMMARY: Cracking along E side of tomb cover and top of cover cracking between cover and vault on E and S sides; light concrete seal.
