CEMETERY SURVEY FORM

SITE NAME: Satala Naval Cemetery (AS-25-055)

LOCATION: Maoputasi County, Tutuila Island, American Samoa

PLOT IDENTIFICATION: 134

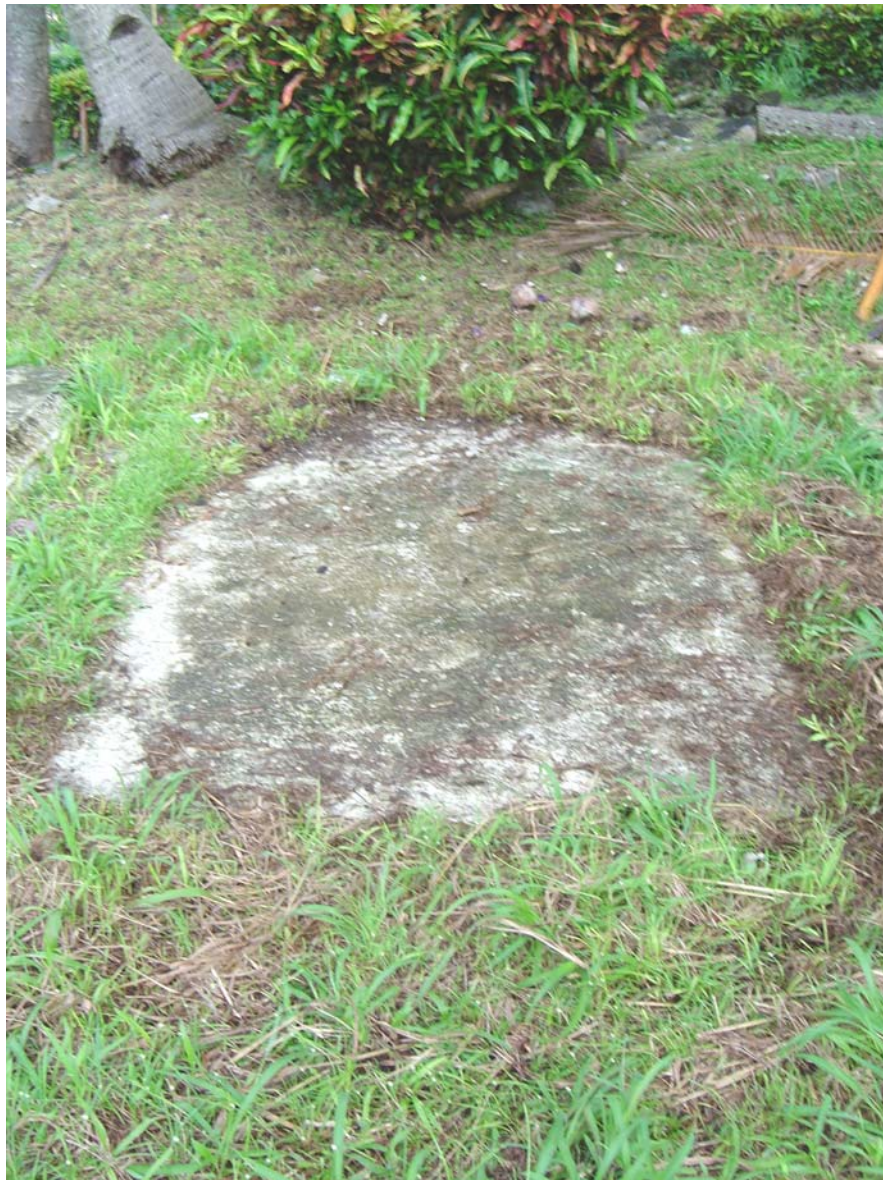
PHOTO:

SUMMARY: Concrete surface slab is flush with ground; possibly sunken? White paint flaking on surface.
