CEMETERY SURVEY FORM

SITE NAME: Satala Naval Cemetery (AS-25-055)

PLOT IDENTIFICATION: 135

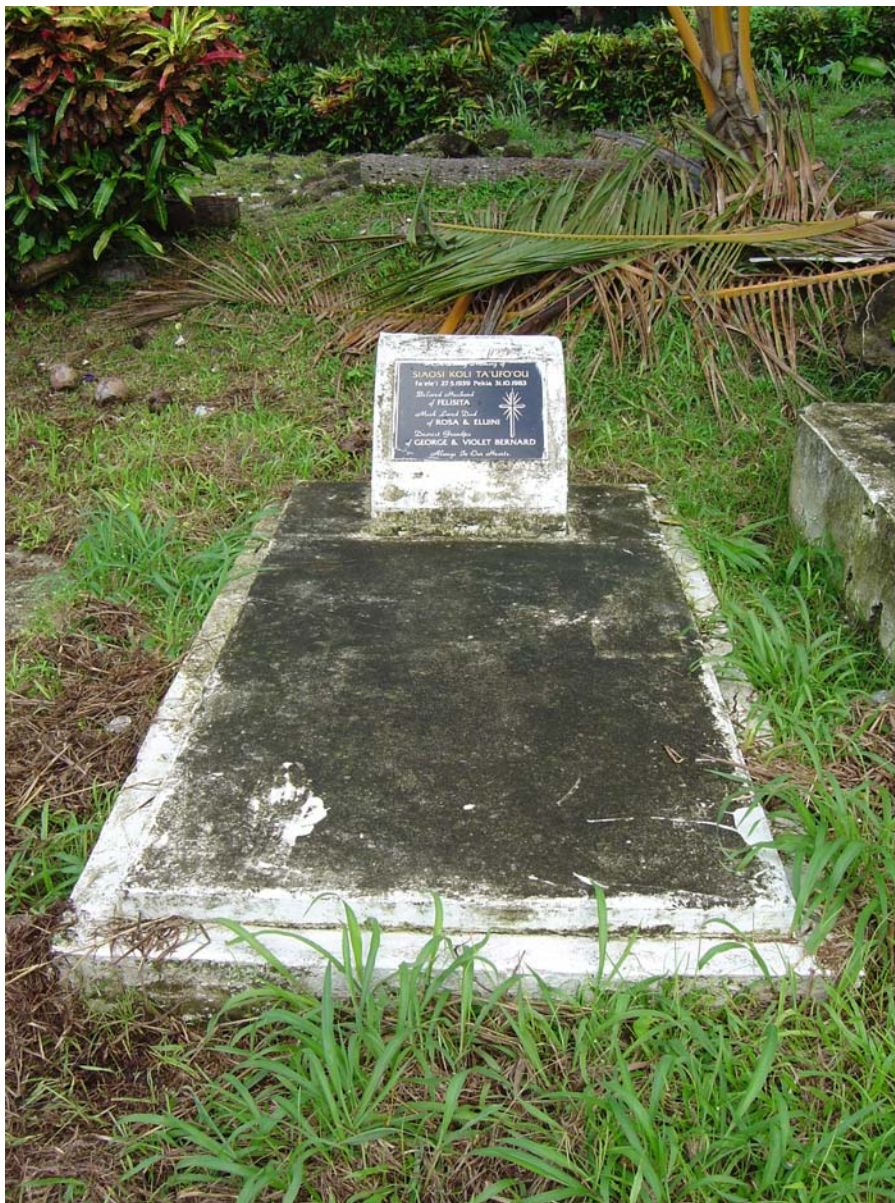
PHOTO:

EXISTING CONDITION	CONSERVATION STRATEGY
<p>POSITION: fallen unstable overgrown tilted marker/ base other <u>stable</u></p> <p>DETERIORATION: broken cracked losses flaking/sugaring delaminations/detachment other <u>none</u></p> <p>SOILING: <u>biological</u> general graffiti efflorescence <u>painting</u> other</p> <p>FAILED TREATMENTS: N/A metal adhesives/coatings mortar other <u>none</u></p>	<p>POSITION: reset in ground reset to existing base resquare botom edge remove fragments in setting slot construct new base possible new base required stabilize foundation</p> <p>DETERIORATION: structural adhesion repair mortars crack fillers flowable grouts consolidation</p> <p>SOILING: chemical <u>pressure wash</u> poultice air abrasion</p> <p>FAILED TREATMENTS: drill/grind hand tools solvents air abrasion</p>

SUMMARY: Plaque base and primary structure base are painted; surface slab unpainted
grave looks as if it is tended to occasionally.
