CEMETERY SURVEY FORM

SITE NAME: Satala Naval Cemetery (AS-25-055)

PLOT IDENTIFICATION: 136

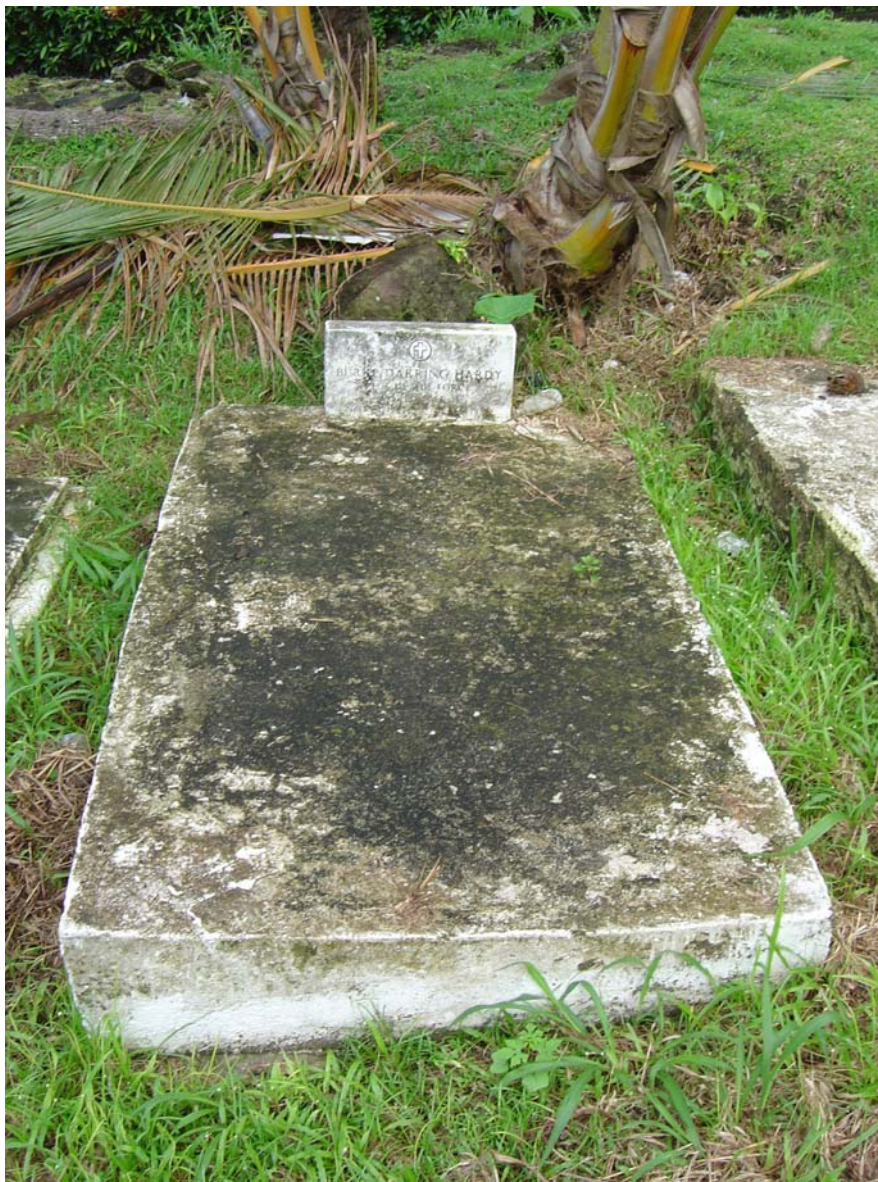
PHOTO:

SUMMARY: White paint flaking off primary structure; thin cracks found. Width long at foot of primary structure.
