CEMETERY SURVEY FORM

SITE NAME: Satala Naval Cemetery (AS-25-055)

PLOT IDENTIFICATION: 137

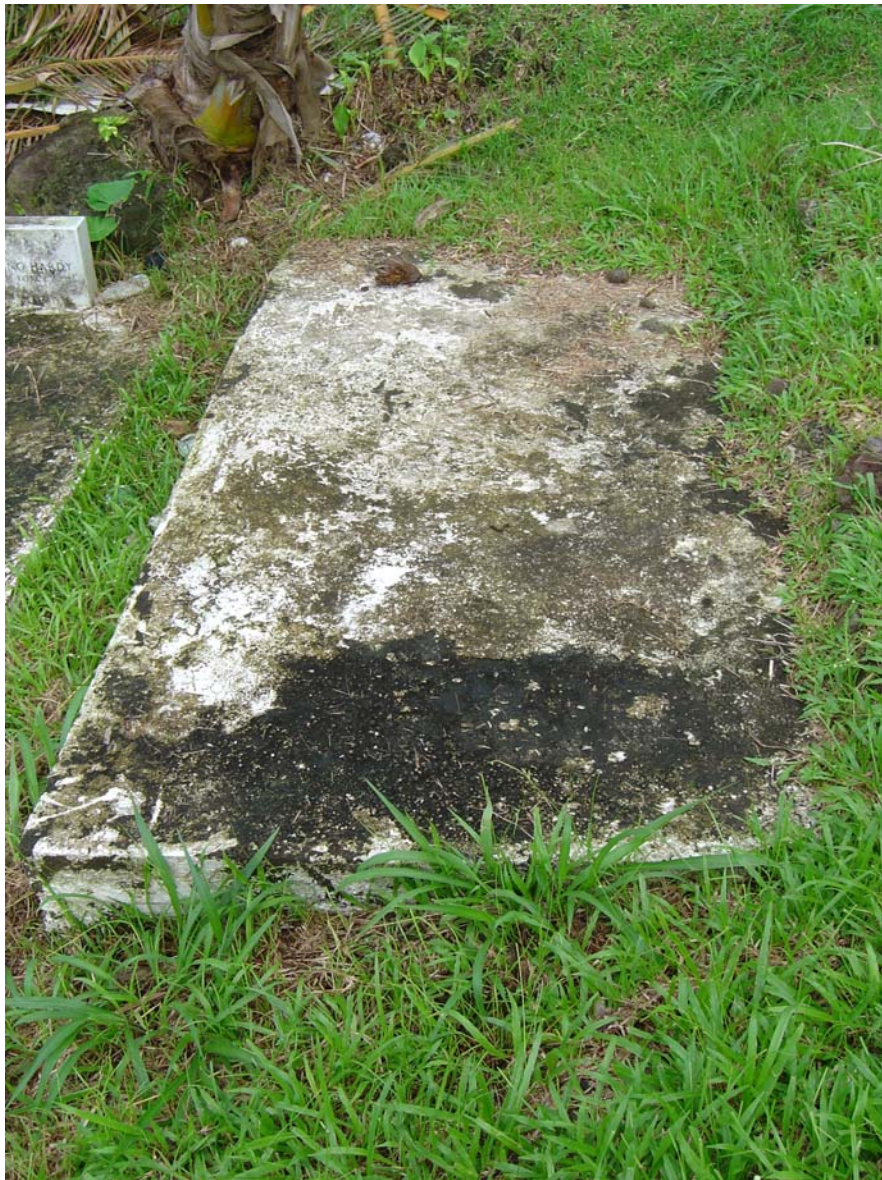
PHOTO:

SUMMARY: Paint flaking on entire grave; rough S edge possible loss or possible construction style.

ongoing deterioration/treatment required 2-5 years **re-inspect in 5 years**
