# CEMETERY SURVEY FORM

SITE NAME: Satala Naval Cemetery (AS-25-055)

PLOT IDENTIFICATION: 138

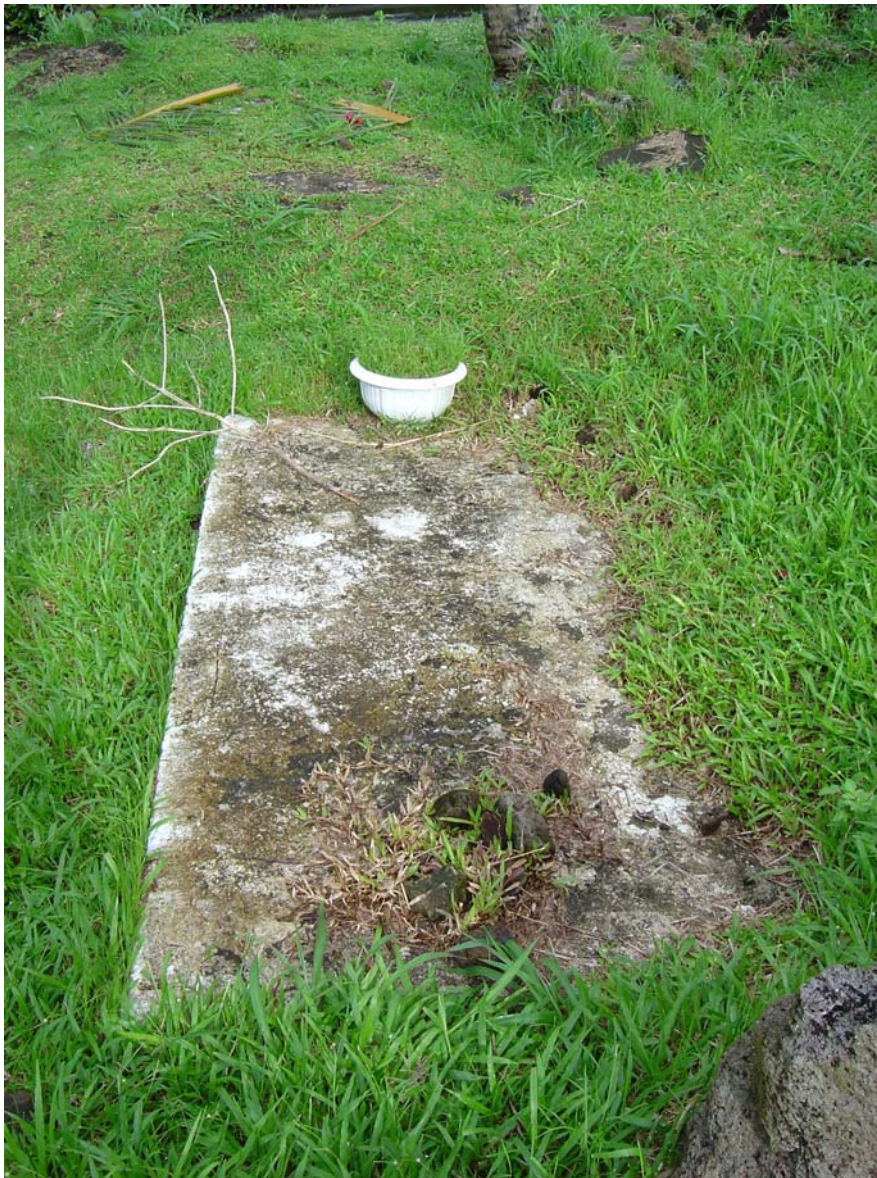
PHOTO:

EXISTING CONDITION	CONSERVATION STRATEGY
<p>POSITION: fallen unstable <b>overgrown</b> tilted marker/ base other _____</p> <p>DETERIORATION: broken cracked losses flaking/sugaring delaminations/detachment other _____</p> <p>SOILING: <b>biological</b> general graffiti efflorescence <b>painting</b> other</p> <p>FAILED TREATMENTS: metal adhesives/coatings mortar other _____</p>	<p>POSITION: reset in ground reset to existing base resquare botom edge remove fragments in setting slot construct new base possible new base required stabilize foundation</p> <p>DETERIORATION: structural adhesion repair mortars crack fillers flowable grouts consolidation</p> <p>SOILING: chemical pressure wash poultice air abrasion</p> <p>FAILED TREATMENTS: drill/grind hand tools solvents air abrasion</p>

SUMMARY: Slab on freestacked rock base; N edge unknown, highly overgrown as is entire base; one temporary plastic urn on W end of primary structure.
