CEMETERY SURVEY FORM

SITE NAME: Satala Naval Cemetery (AS-25-055)

PLOT IDENTIFICATION: 139

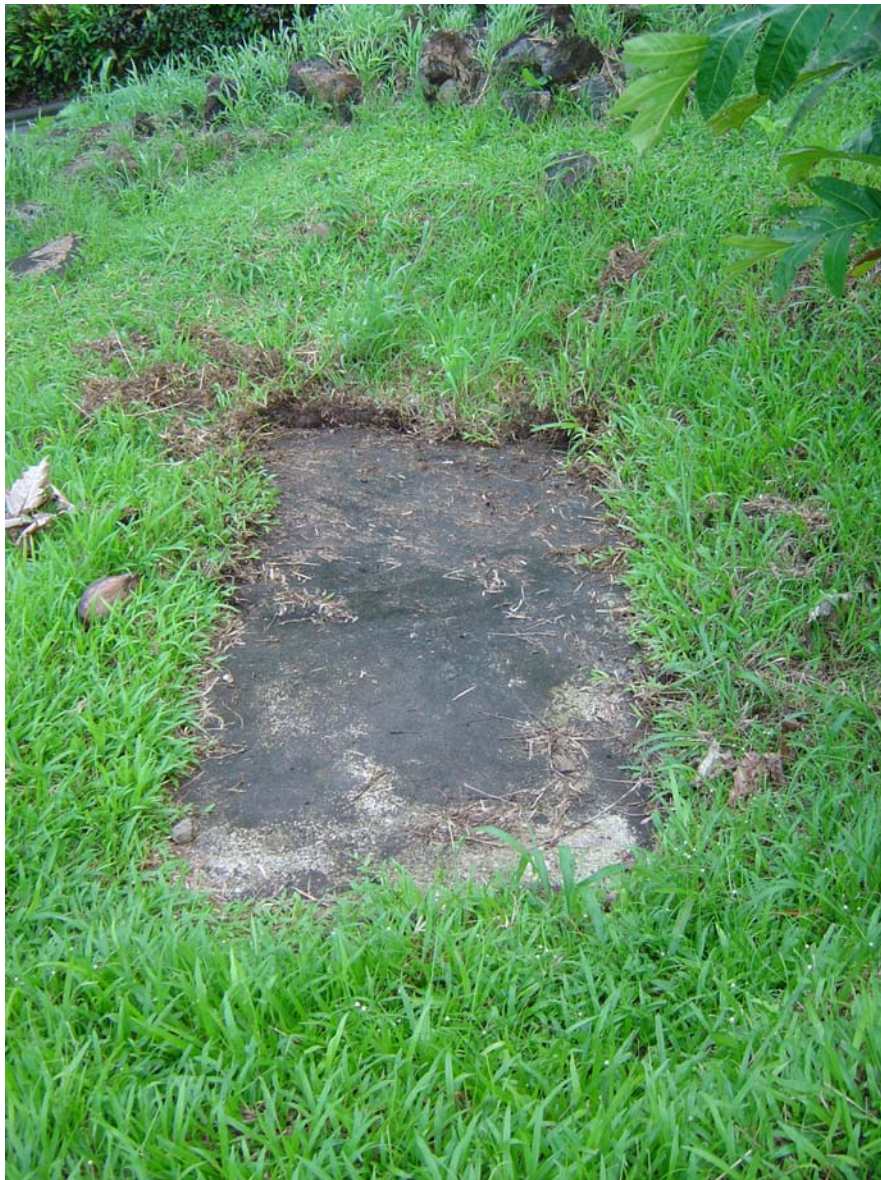
PHOTO:

SUMMARY: Plot overgrown, primary structure flush with ground level; possible freestack rock base undeterminable;

ongoing deterioration/treatment required 2-5 years **re-inspect in 5 years**
