CEMETERY SURVEY FORM

SITE NAME: Satala Naval Cemetery

PLOT IDENTIFICATION: 14

NAME(S) OF INTERRED: MRS. P. SCHWENKE

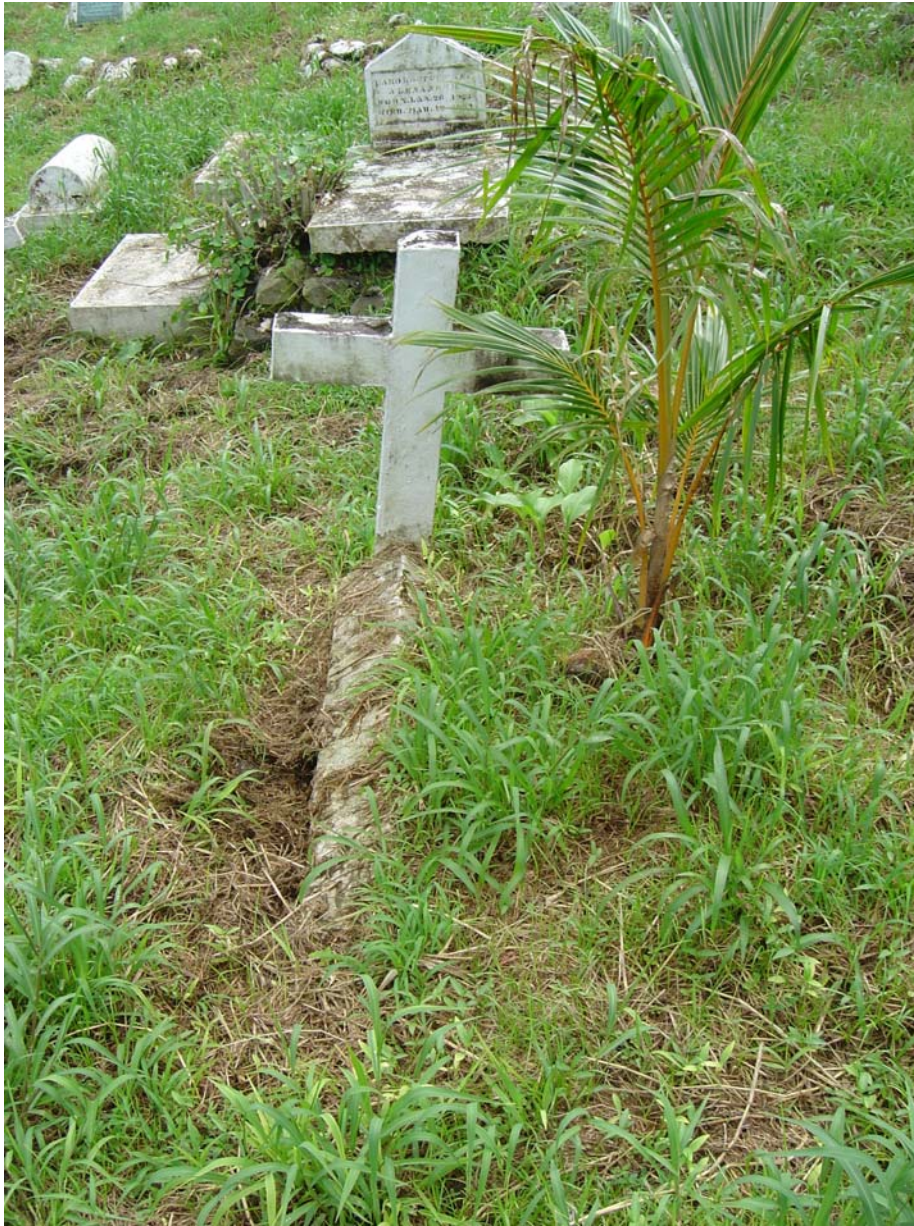
PHOTO:

SUMMARY: So overgrown base not visible, covered in thick white paint and mildew.

Cross missing chunks.

hazardous/immediate action **unstable deterioration/ASAP**
