CEMETERY SURVEY FORM

SITE NAME: Satala Naval Cemetery

LOCATION: Maoputasi County, Tutuila Island, American Samoa

PLOT IDENTIFICATION: 140

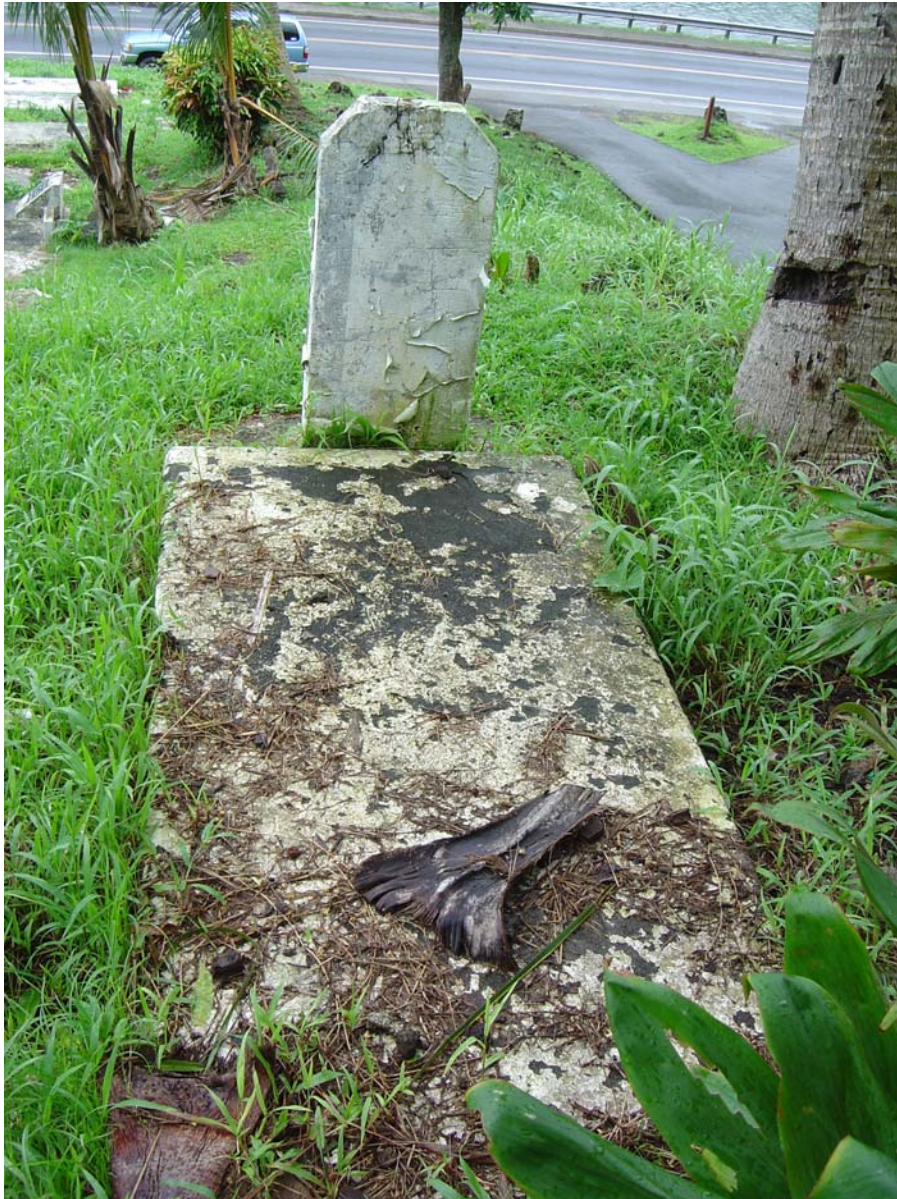
PHOTO:

SUMMARY: Some cracks and losses in the primary structure. Cracks found in footstone. Paint and mildew need to be removed.
