CEMETERY SURVEY FORM

SITE NAME: Satala Naval Cemetery

LOCATION: Maoputasi County, Tutuila Island, American Samoa

PLOT IDENTIFICATION: 141

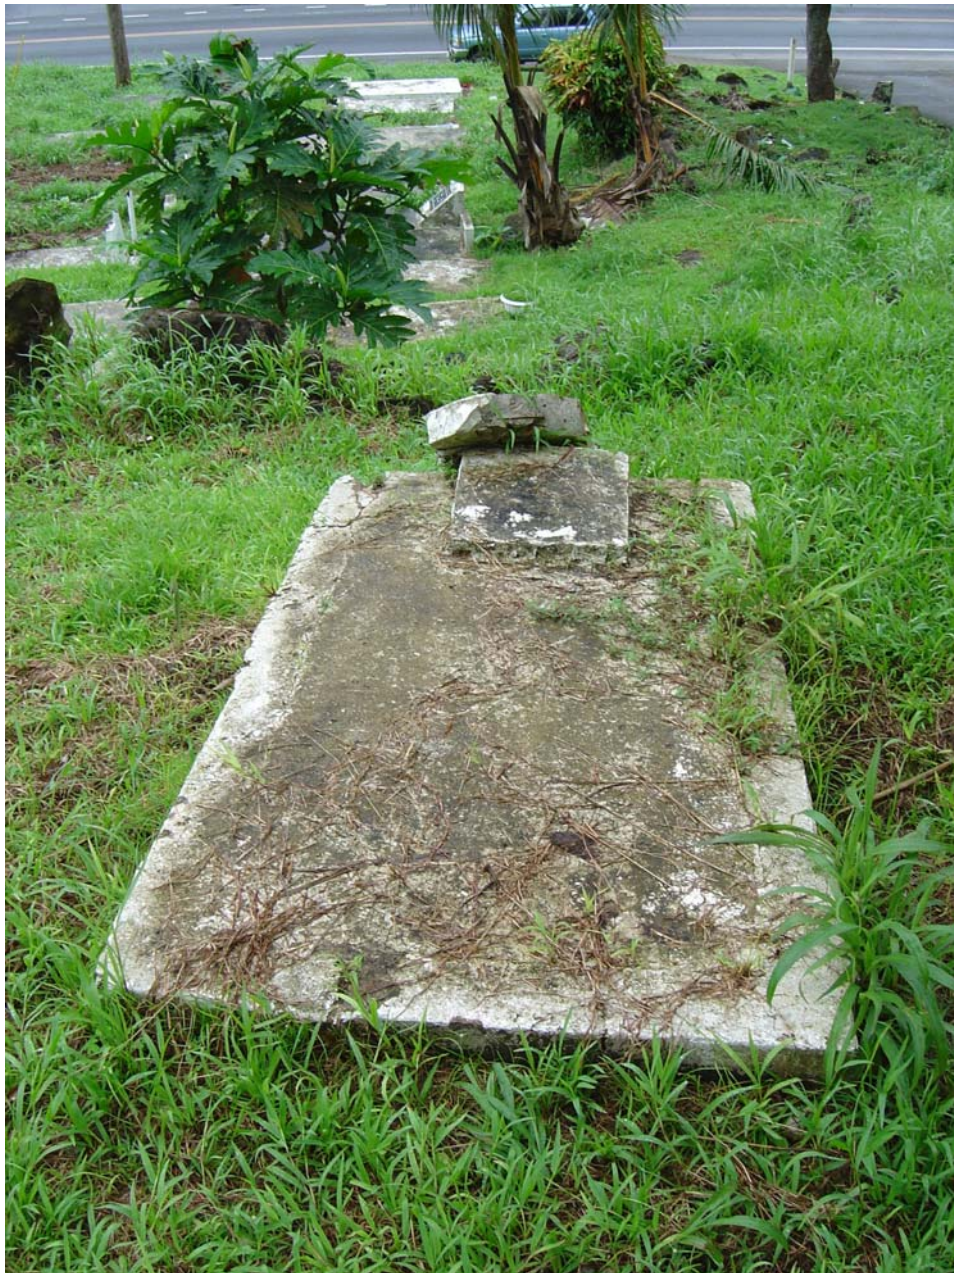
PHOTO:

SUMMARY: Some cracks and losses in the primary structure around the edges.

Footstone broken in half. Propped up fragment may be relocated from Grave 142.. Paint and mildew need to be removed.
