CEMETERY SURVEY FORM

SITE NAME: Satala Naval Cemetery

LOCATION: Maoputasi County, Tutuila Island, American Samoa

PLOT IDENTIFICATION: 142

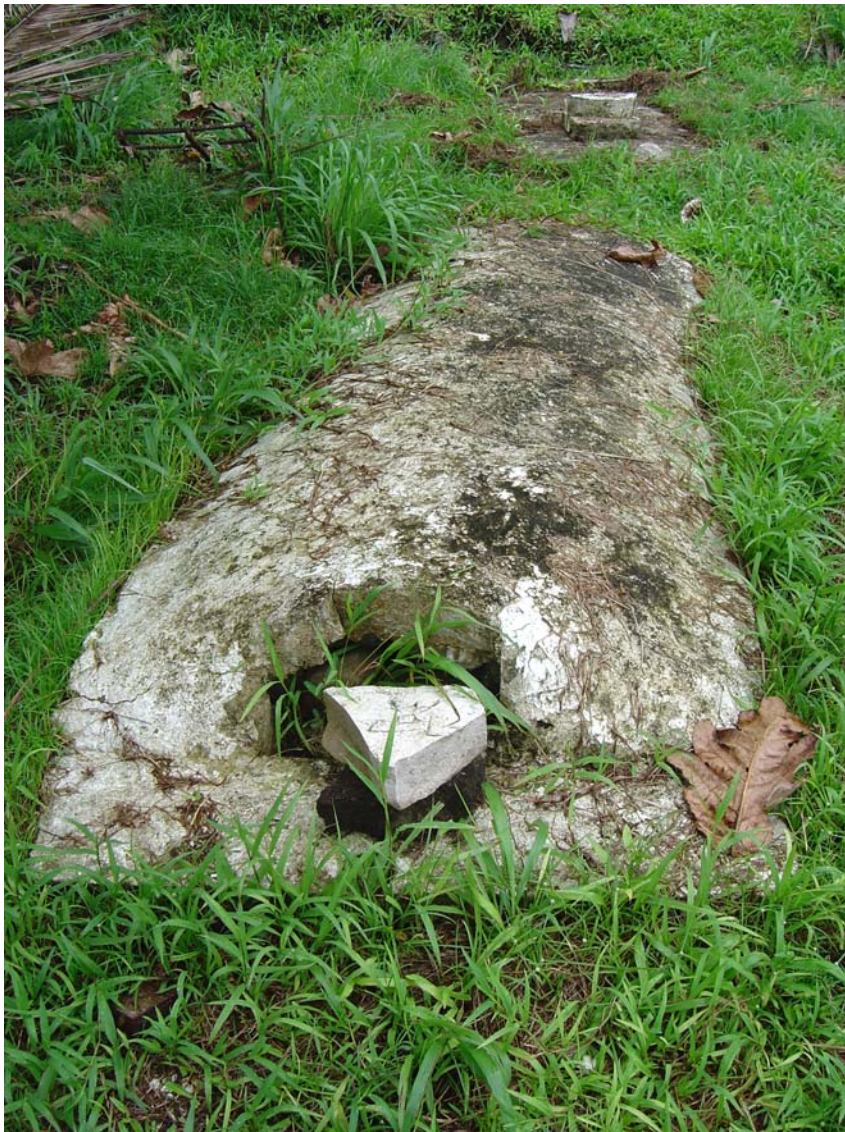
PHOTO:

SUMMARY: Some cracks and losses in the primary structure around the edges. Large hole in primary structure where footstone was most likely attached. Footstone broken and missing with only one fragment remaining. Paint and mildew need to be removed.
