CEMETERY SURVEY FORM

SITE NAME: Satala Naval Cemetery

LOCATION: Maoputasi County, Tutuila Island, American Samoa

PLOT IDENTIFICATION: 143

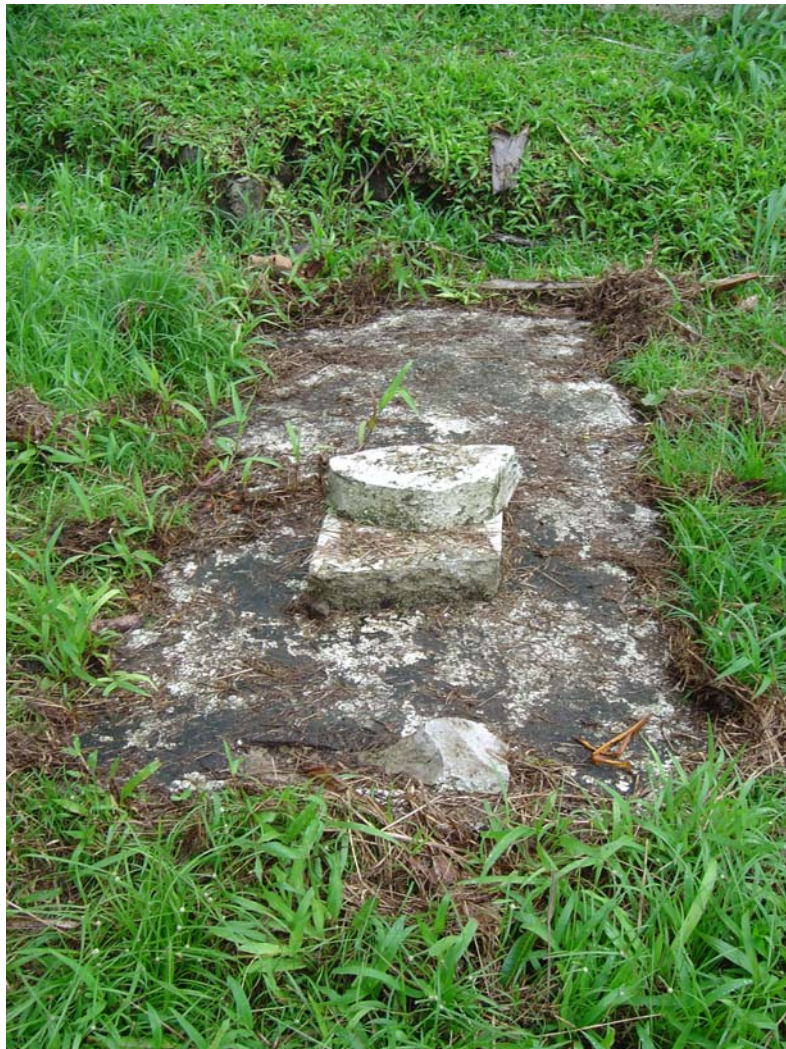
PHOTO:

SUMMARY: Some cracks and losses in the primary structure around the edges. Large hole in primary structure where footstone was most likely attached. Footstone broken and missing with two fragments on primary structure and one still rooted in base. Paint and mildew need to be removed.
