CEMETERY SURVEY FORM

SITE NAME: Satala Naval Cemetery

PLOT IDENTIFICATION: 144

NAME(S) OF INTERRED: Ching Dong Lin

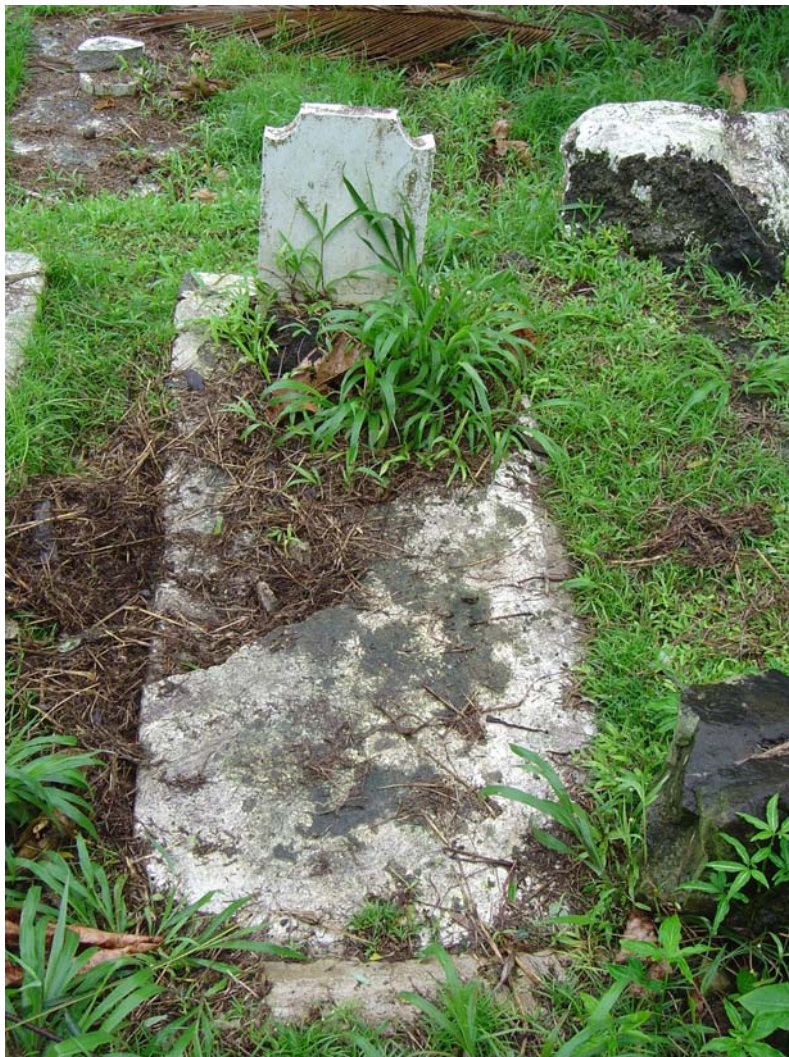
PHOTO:

hazardous/immediate action **unstable deterioration/ASAP**

SUMMARY: Primary structure broken in half with some crack and losses around the edges. Vegetation growing out of broken area. The primary structure is tilted at break. Footstone in place. Paint, mildew, and vegetation need to be removed.
