CEMETERY SURVEY FORM

SITE NAME: Satala Naval Cemetery

PLOT IDENTIFICATION: 145

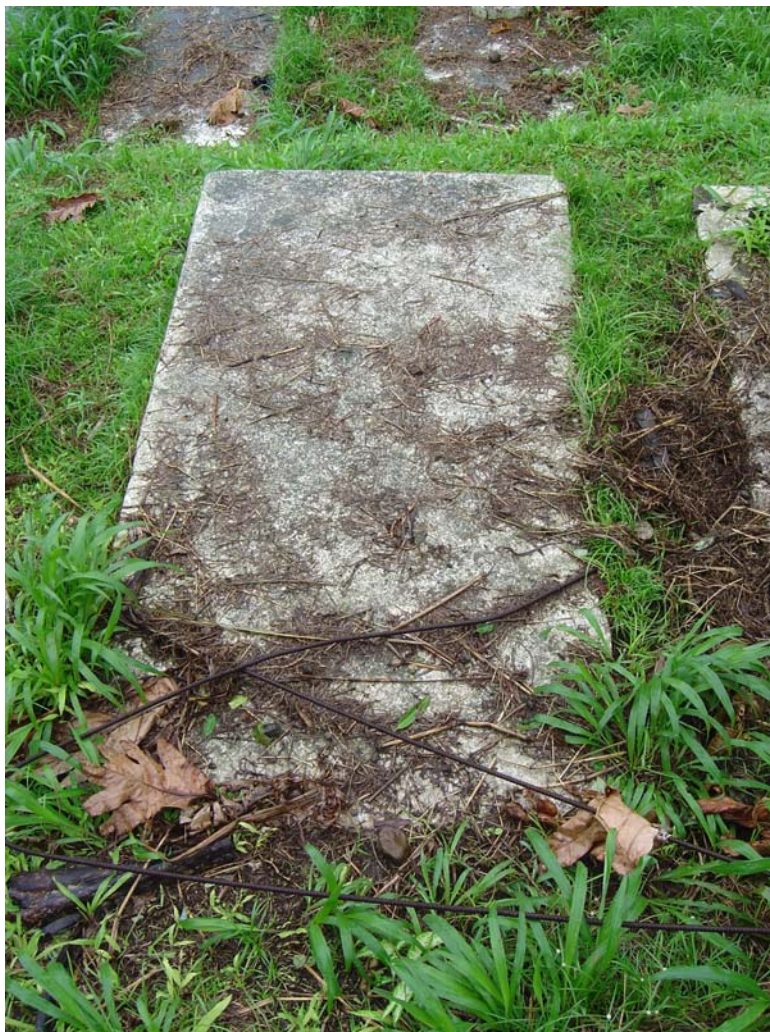
PHOTO:

SUMMARY: Paint and mildew need to be removed.
