# CEMETERY SURVEY FORM

SITE NAME: Satala Naval Cemetery

PLOT IDENTIFICATION: 146

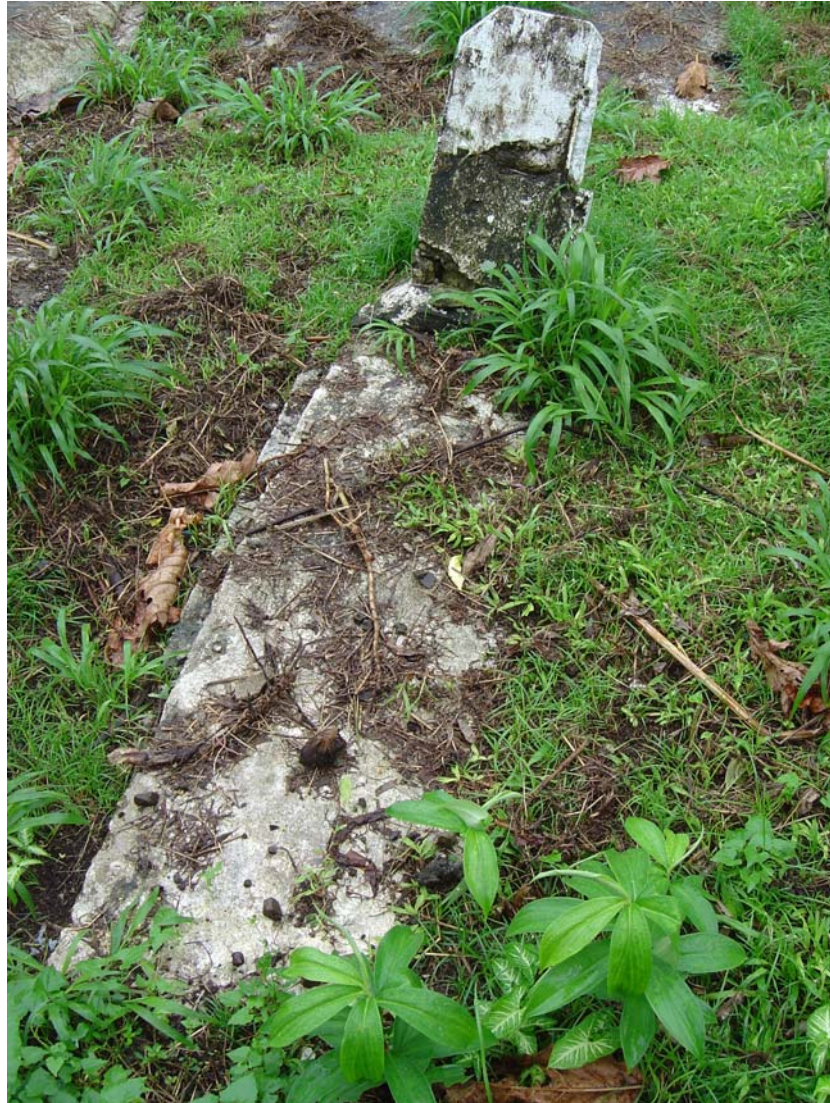
PHOTO:

EXISTING CONDITION	CONSERVATION STRATEGY
<p>POSITION: fallen unstable <b>overgrown</b> tilted marker/ base other _____</p> <p>DETERIORATION: <b>broken cracked losses</b> flaking/sugaring delaminations/detachment other _____</p> <p>SOILING: <b>biological</b> general graffiti efflorescence <b>painting</b> other</p> <p>FAILED TREATMENTS: metal adhesives/coatings mortar other _____</p>	<p>POSITION: reset in ground reset to existing base resquare botom edge remove fragments in setting slot construct new base possible new base required stabilize foundation</p> <p>DETERIORATION: structural adhesion repair mortars crack fillers flowable grouts consolidation</p> <p>SOILING: chemical pressure wash poultice air abrasion</p> <p>FAILED TREATMENTS: drill/grind hand tools solvents air abrasion</p>

SUMMARY: Primary structure has cracks and losses. The entire grave is tilted to the west and is partially buried on that side. Vegetation is growing in the cracks throughout the primary structure. Footstone is broken through the middle. Paint and mildew need to be removed.
