CEMETERY SURVEY FORM

SITE NAME: Satala Naval Cemetery

PLOT IDENTIFICATION: 147

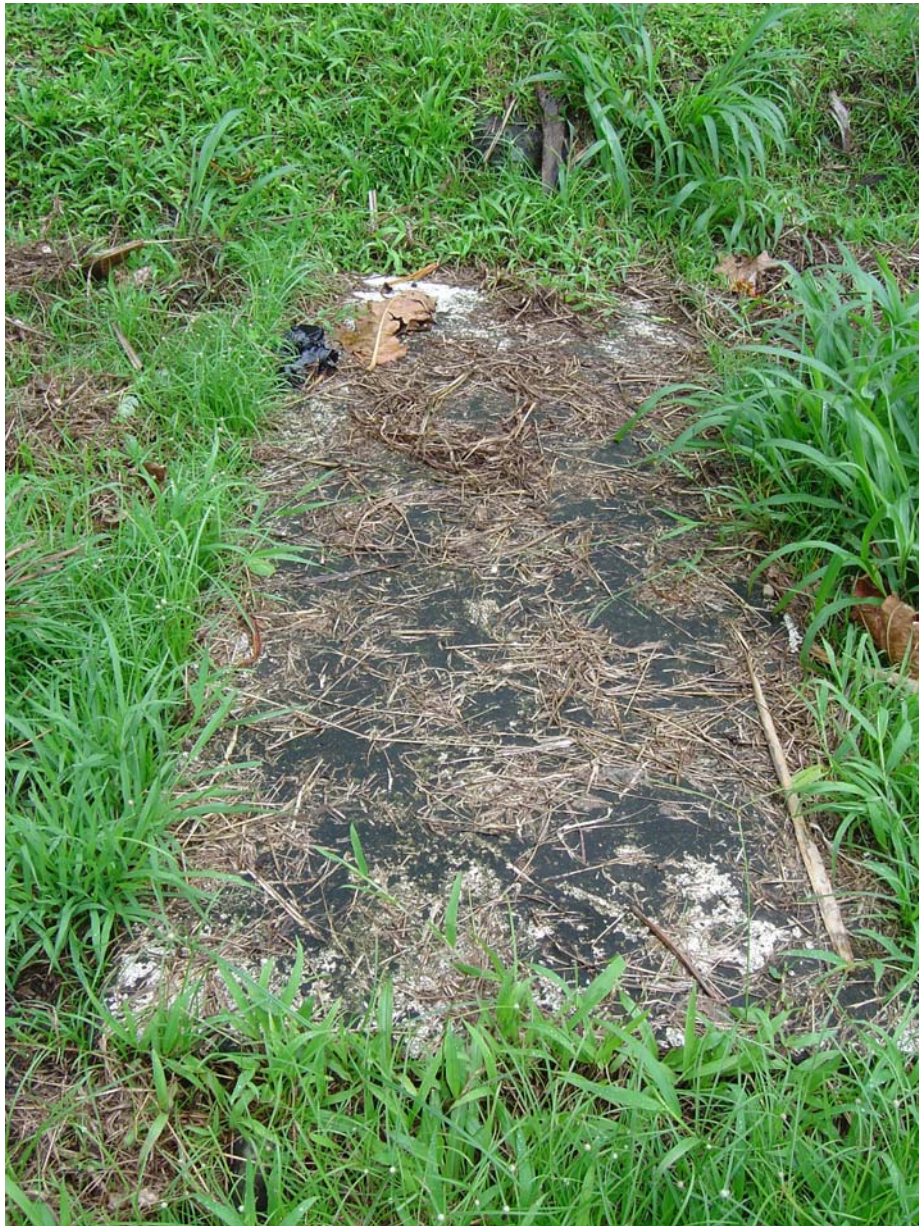
PHOTO:

SUMMARY: Paint and mildew need to be removed.
