# CEMETERY SURVEY FORM

SITE NAME: Satala Naval Cemetery

PLOT IDENTIFICATION: 148

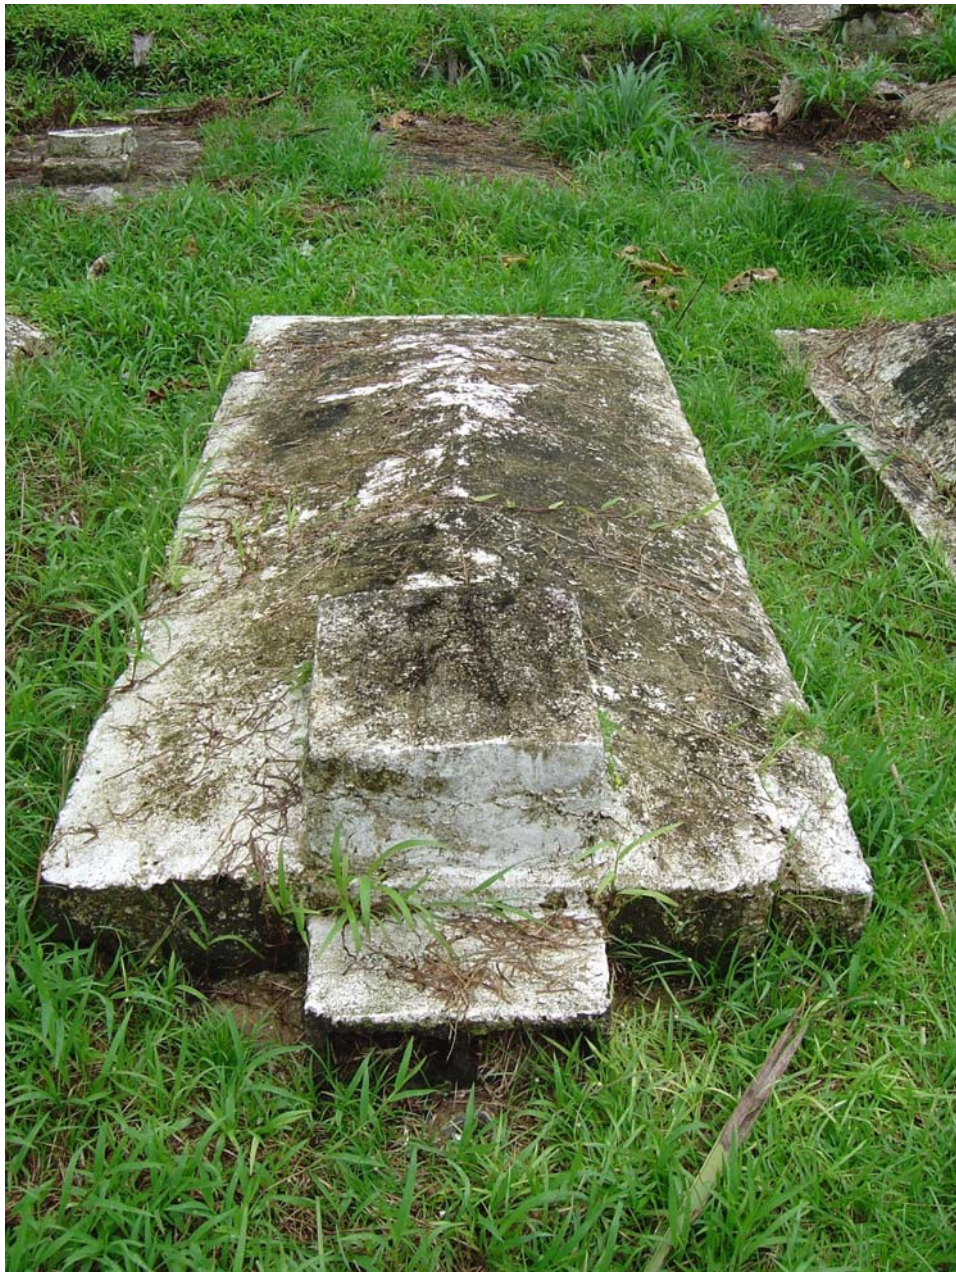
PHOTO:

EXISTING CONDITION	CONSERVATION STRATEGY
<p><b>POSITION:</b>                      fallen unstable <b>overgrown</b>                      tilted marker/ base other _____</p> <p><b>DETERIORATION:</b>                      broken cracked losses flaking/sugaring                      delaminations/detachment                      other _____</p> <p><b>SOILING:</b>  <b>biological</b> general graffiti efflorescence  <b>painting</b> other</p> <p><b>FAILED TREATMENTS:</b>                      metal adhesives/coatings mortar                      other _____</p>	<p><b>POSITION:</b>                      reset in ground                      reset to existing base                      resquare botom edge                      remove fragments in setting slot                      construct new base                      possible new base required                      stabilize foundation</p> <p><b>DETERIORATION:</b>                      structural adhesion repair mortars                      crack fillers flowable grouts                      consolidation</p> <p><b>SOILING:</b>                      chemical pressure wash                      poultice air abrasion</p> <p><b>FAILED TREATMENTS:</b>                      drill/grind hand tools solvents                      air abrasion</p>

SUMMARY: Paint and mildew need to be removed.
