# CEMETERY SURVEY FORM

SITE NAME: Satala Naval Cemetery

PLOT IDENTIFICATION: 149

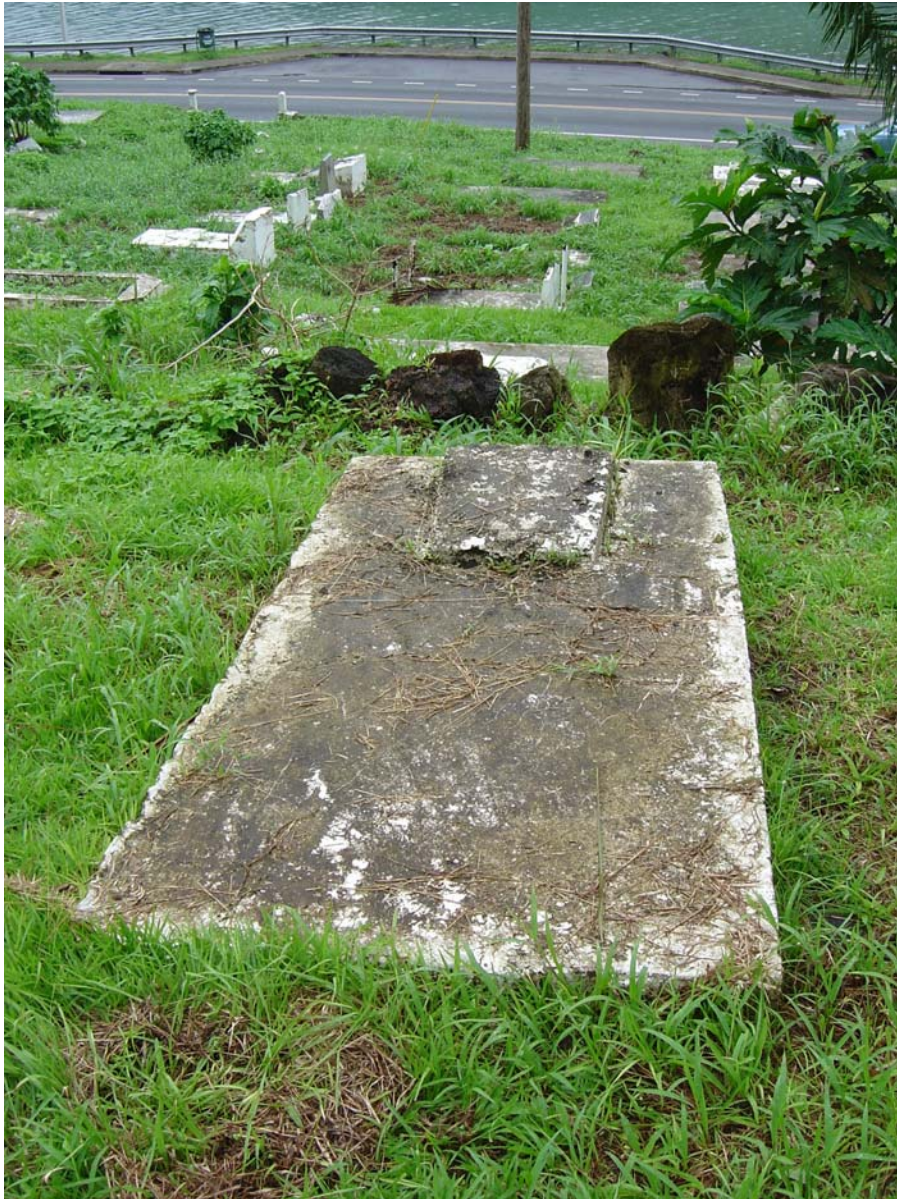
PHOTO:

EXISTING CONDITION	CONSERVATION STRATEGY
<p>POSITION: fallen unstable <b>overgrown</b> tilted marker/ base other _____</p> <p>DETERIORATION: broken cracked losses flaking/sugaring delaminations/detachment other _____</p> <p>SOILING: <b>biological</b> general graffiti efflorescence <b>painting</b> other</p> <p>FAILED TREATMENTS: metal adhesives/coatings mortar other _____</p>	<p>POSITION: reset in ground reset to existing base resquare botom edge remove fragments in setting slot construct new base possible new base required stabilize foundation</p> <p>DETERIORATION: structural adhesion repair mortars crack fillers flowable grouts consolidation</p> <p>SOILING: chemical pressure wash poultice air abrasion</p> <p>FAILED TREATMENTS: drill/grind hand tools solvents air abrasion</p>

SUMMARY: . Paint and mildew need to be removed.
