CEMETERY SURVEY FORM

SITE NAME: Satala Naval Cemetery

PLOT IDENTIFICATION: 15

NAME(S) OF INTERRED: HARRY TRUMAN ALEXANDER

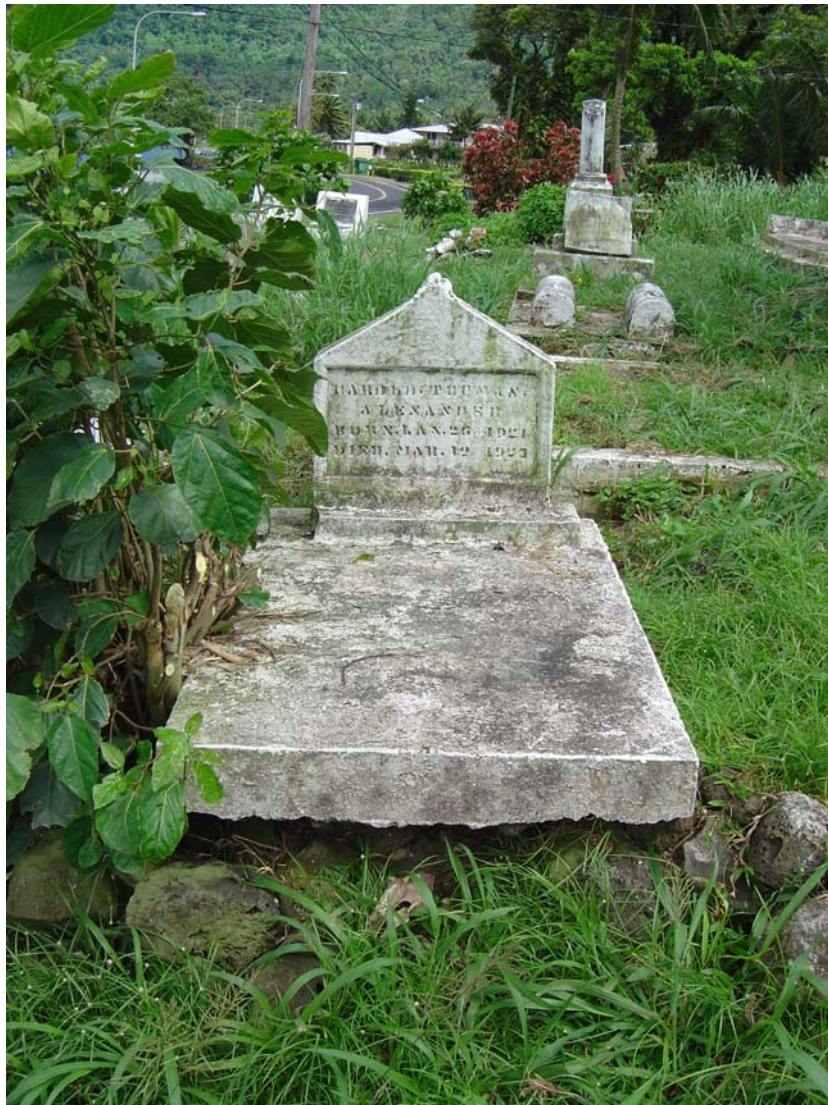
PHOTO:

SUMMARY: Primary structure looks like it has been relocated, covered in thick white paint and mildew.

Headstone: base is chipped with large chunks gone; ornament missing from top (possibly cross on 13).
