CEMETERY SURVEY FORM

SITE NAME: Satala Naval Cemetery

PLOT IDENTIFICATION: 150

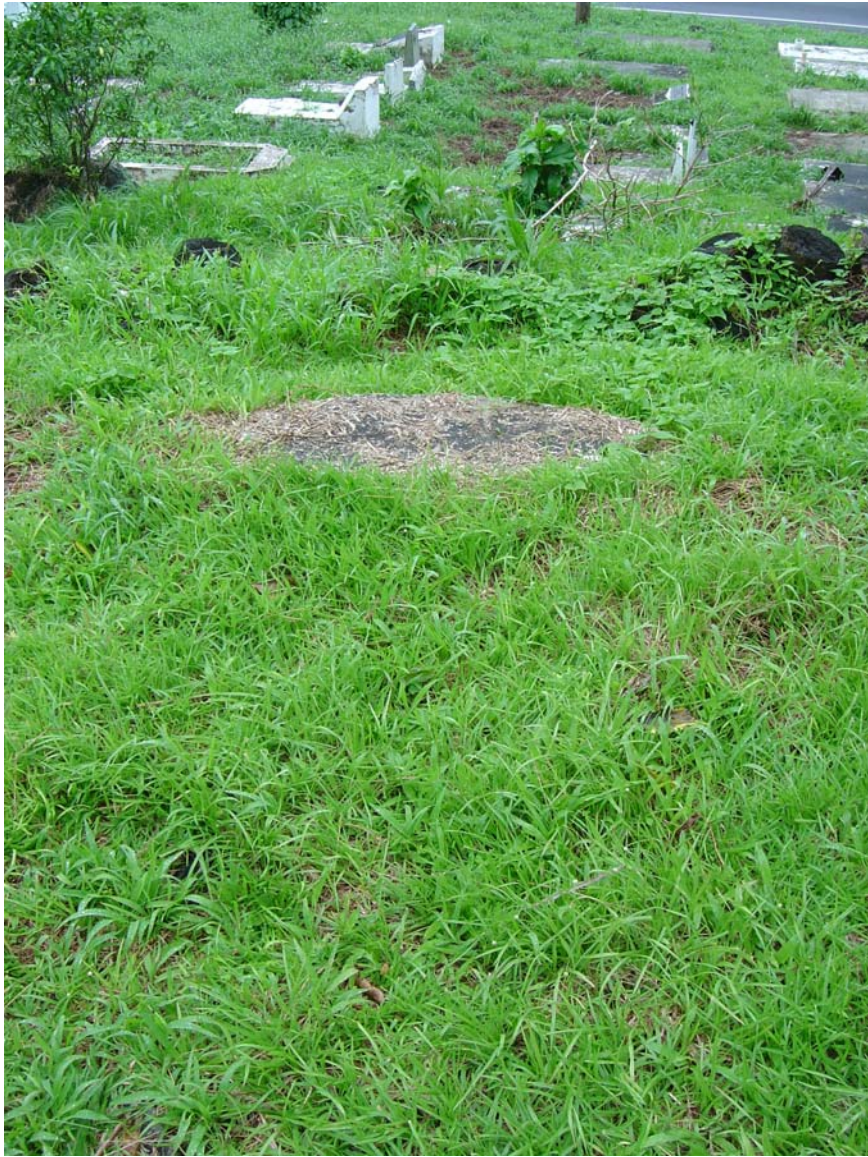
PHOTO:

SUMMARY: Mildew needs to be removed.
