CEMETERY SURVEY FORM

SITE NAME: Satala Naval Cemetery

LOCATION: Maoputasi County, Tutuila Island, American Samoa

PLOT IDENTIFICATION: 151

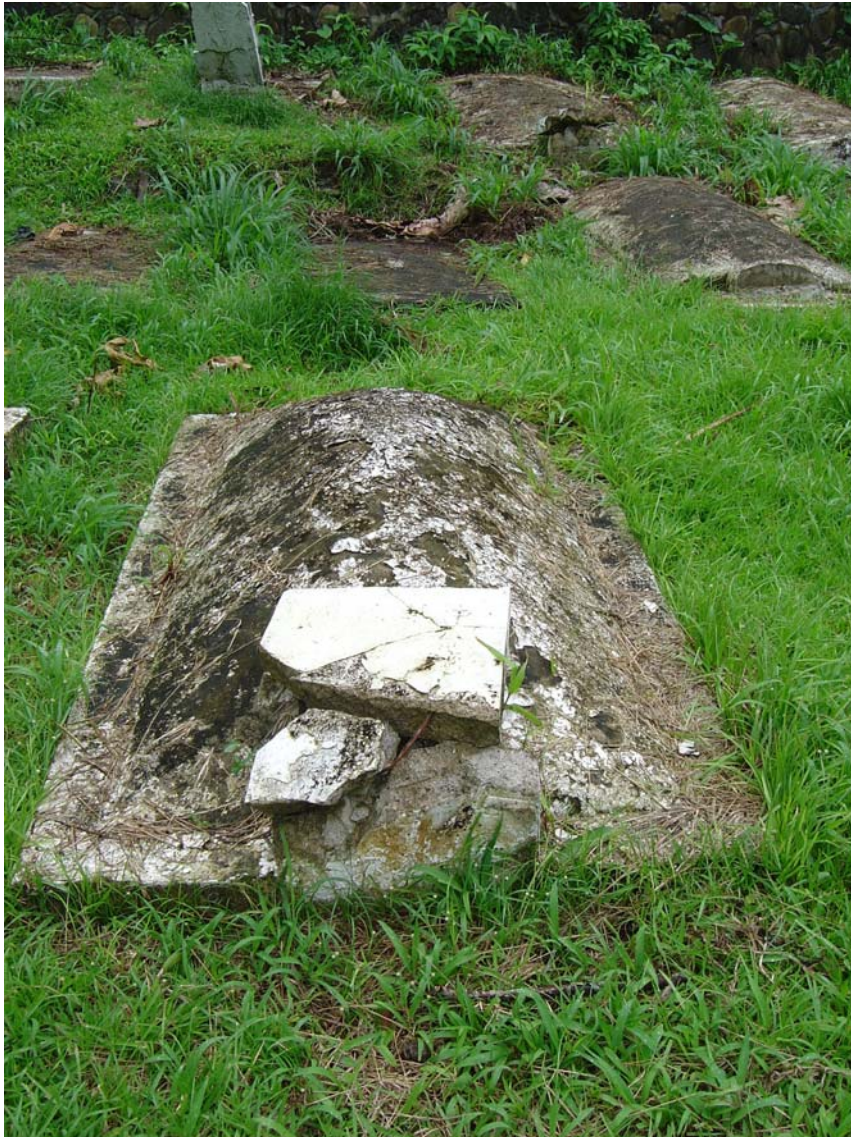
PHOTO:

SUMMARY: Primary structure has some cracks and small losses and large hole from footstone breakage. Footstone has been destroyed with two fragments remaining. Paint and mildew need to be removed.
