CEMETERY SURVEY FORM

SITE NAME: Satala Naval Cemetery

PLOT IDENTIFICATION: 152

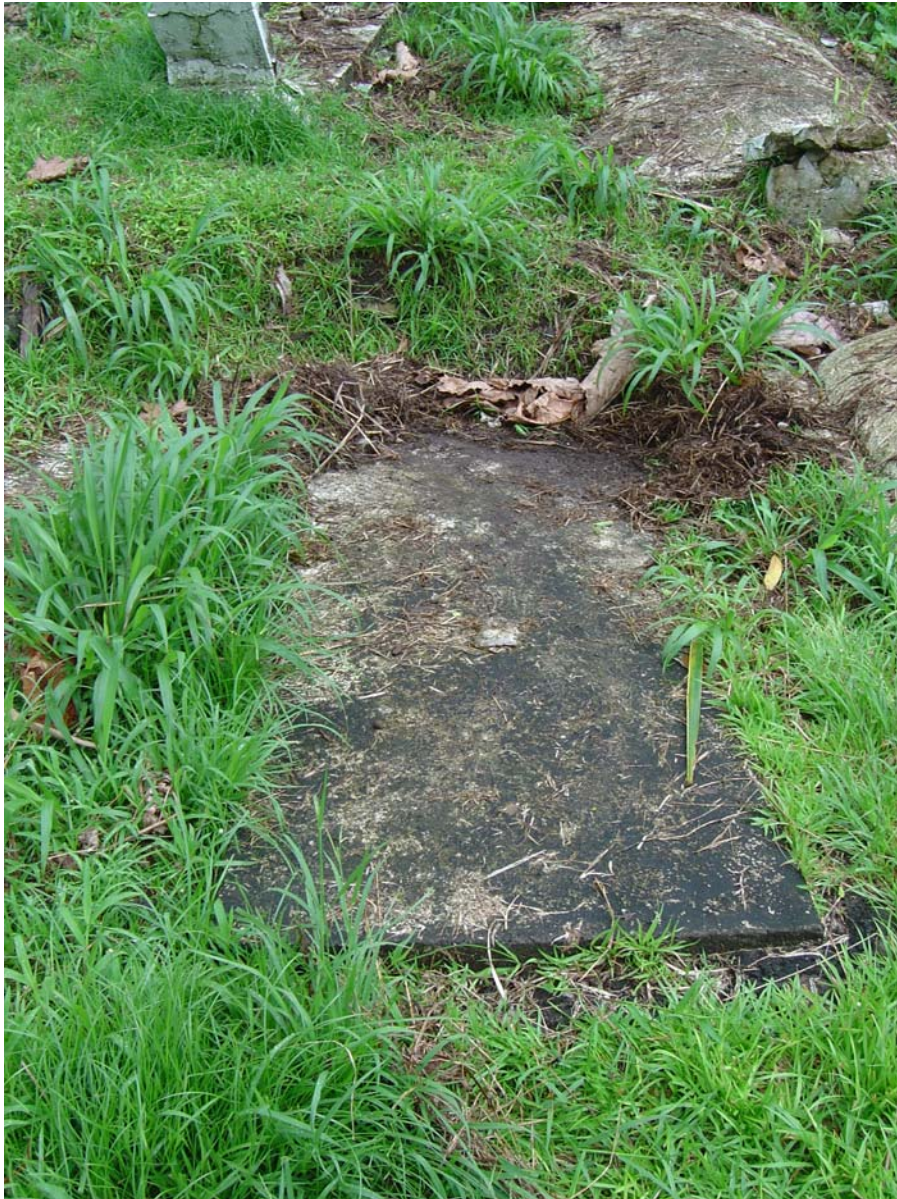
PHOTO:

SUMMARY: Paint and mildew needs to be removed.
