CEMETERY SURVEY FORM

SITE NAME: Satala Naval Cemetery

LOCATION: Maoputasi County, Tutuila Island, American Samoa

PLOT IDENTIFICATION: 154

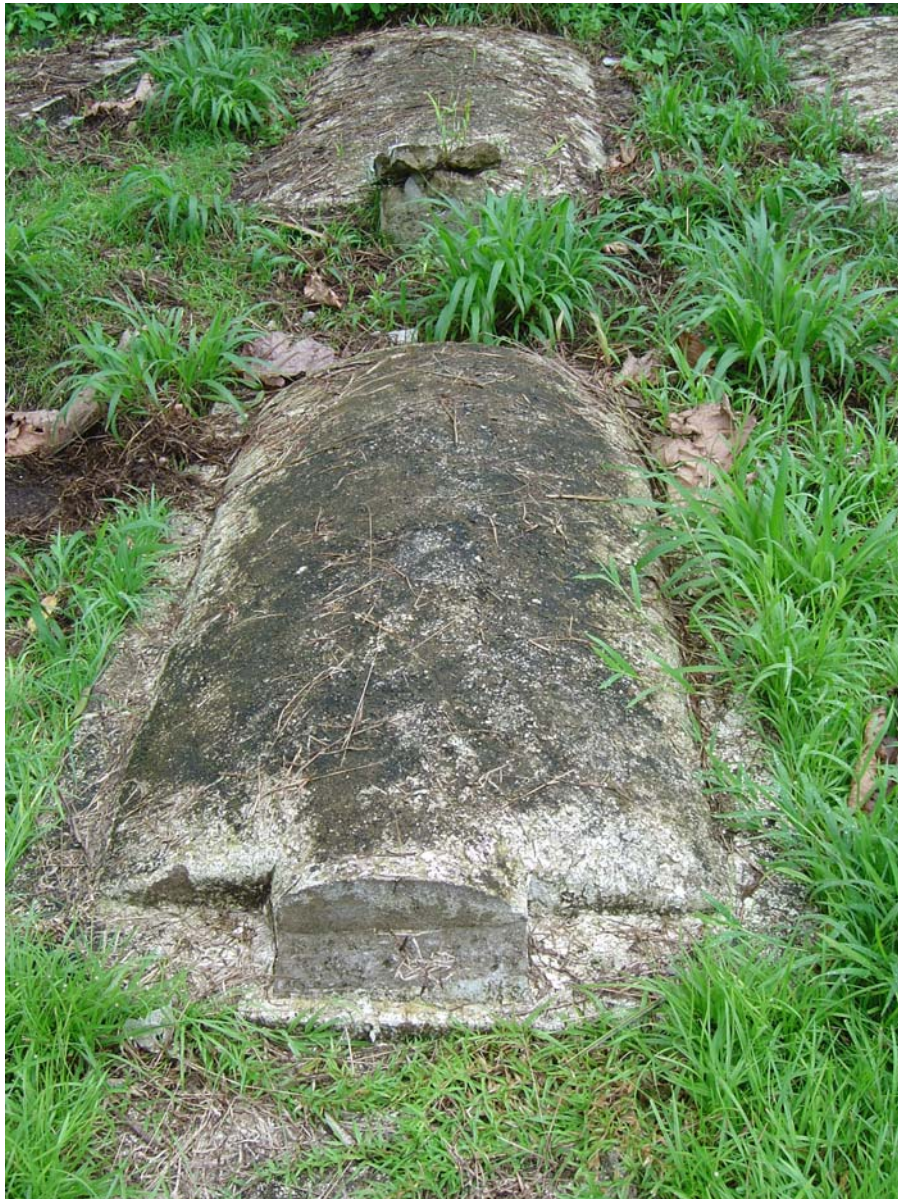
PHOTO:

SUMMARY: Primary structure has some crack and losses. Grave marker is missing from grave. Paint and mildew needs to be removed.
