CEMETERY SURVEY FORM

SITE NAME: Satala Naval Cemetery

SURVEYOR: Erika C. Radewagen, M.A. DATE: March 7, 2005

PLOT IDENTIFICATION: 155

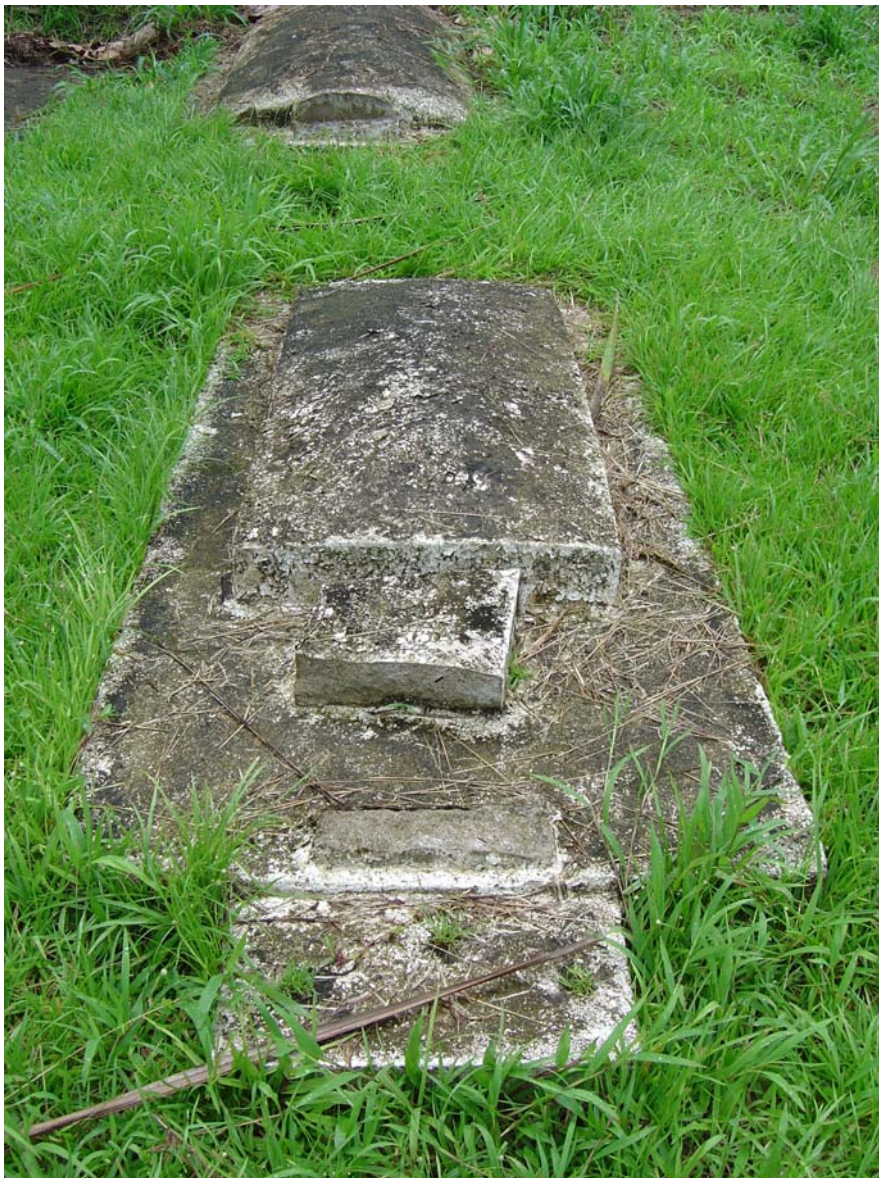
PHOTO:

SUMMARY: Primary structure has some crack and losses. Footstone is broken in half with top half missing. Paint and mildew needs to be removed.
