# CEMETERY SURVEY FORM

SITE NAME: Satala Naval Cemetery

PLOT IDENTIFICATION: 156

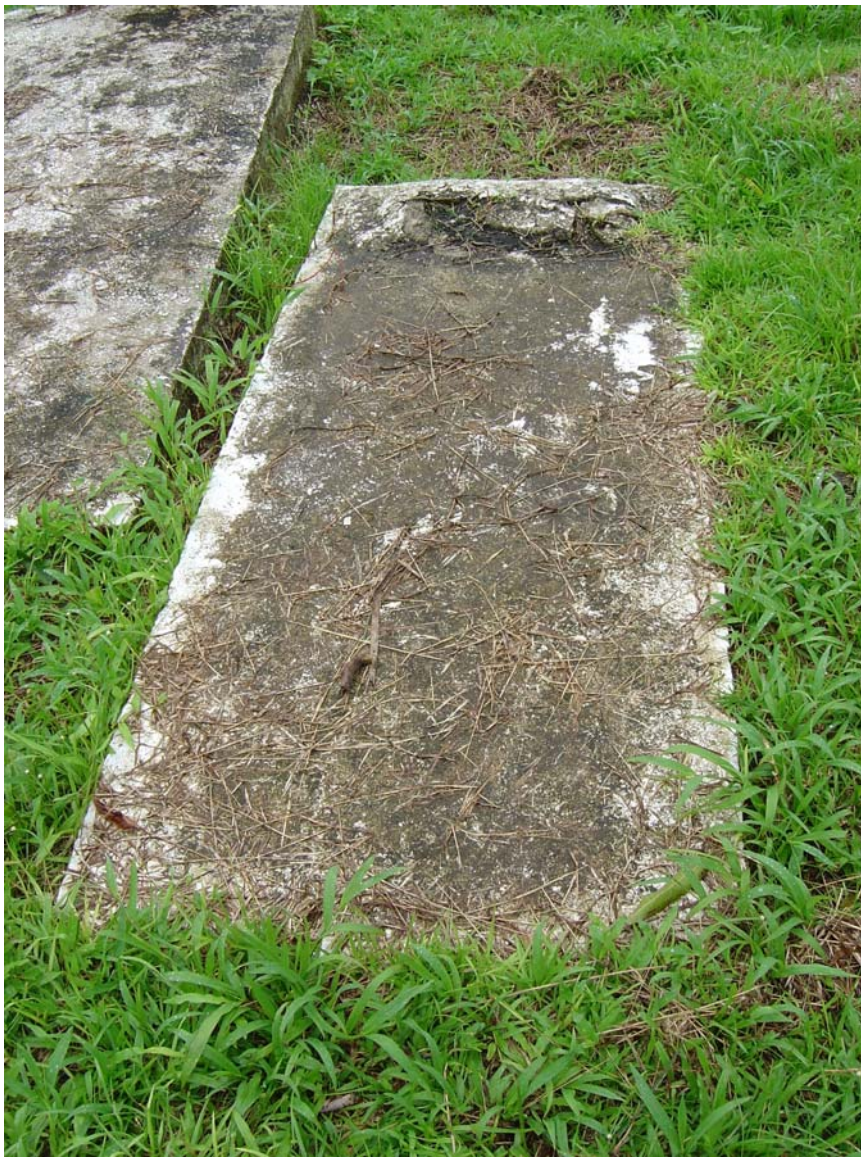
PHOTO:

EXISTING CONDITION	CONSERVATION STRATEGY
<p>POSITION: fallen unstable <b>overgrown</b> tilted marker/ base other _____</p> <p>DETERIORATION: <b>broken cracked losses</b> flaking/sugaring delaminations/detachment other _____</p> <p>SOILING: <b>biological</b> general graffiti efflorescence <b>painting</b> other</p> <p>FAILED TREATMENTS: metal adhesives/coatings mortar other _____</p>	<p>POSITION: reset in ground reset to existing base resquare botom edge remove fragments in setting slot construct new base possible new base required stabilize foundation</p> <p>DETERIORATION: structural adhesion repair mortars crack fillers flowable grouts consolidation</p> <p>SOILING: chemical pressure wash poultice air abrasion</p> <p>FAILED TREATMENTS: drill/grind hand tools solvents air abrasion</p>

SUMMARY: Primary structure has some crack and losses. Grave marker is missing.  
Paint and mildew needs to be removed.
